## EPSON RC+ 4.2.2 Release Notes

July 23, 2008

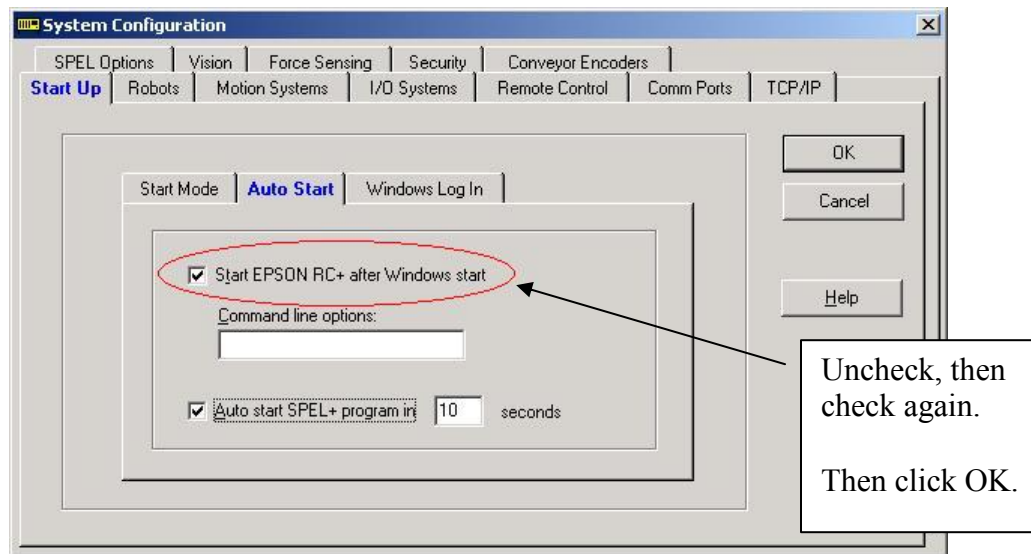
If RC+ was configured to auto start after Windows start, it will no longer start up automatically after upgrading to a 4.x version. This is easily fixed.

1. Run EPSON RC+. Click **Change Startup Mode**. Select **Program / Debug**, then click **OK**.
2. Select Setup->System Configuration. On the **Start Up** tab, click the **Auto Start** tab. Uncheck **Start EPSON RC+ after Windows start**. Then check it again. Click **OK**.
