by Tom Dougherty

USS *Dolphin* (AGSS-555) - The "Triple Nickel" - The Last U.S. Diesel Submarine

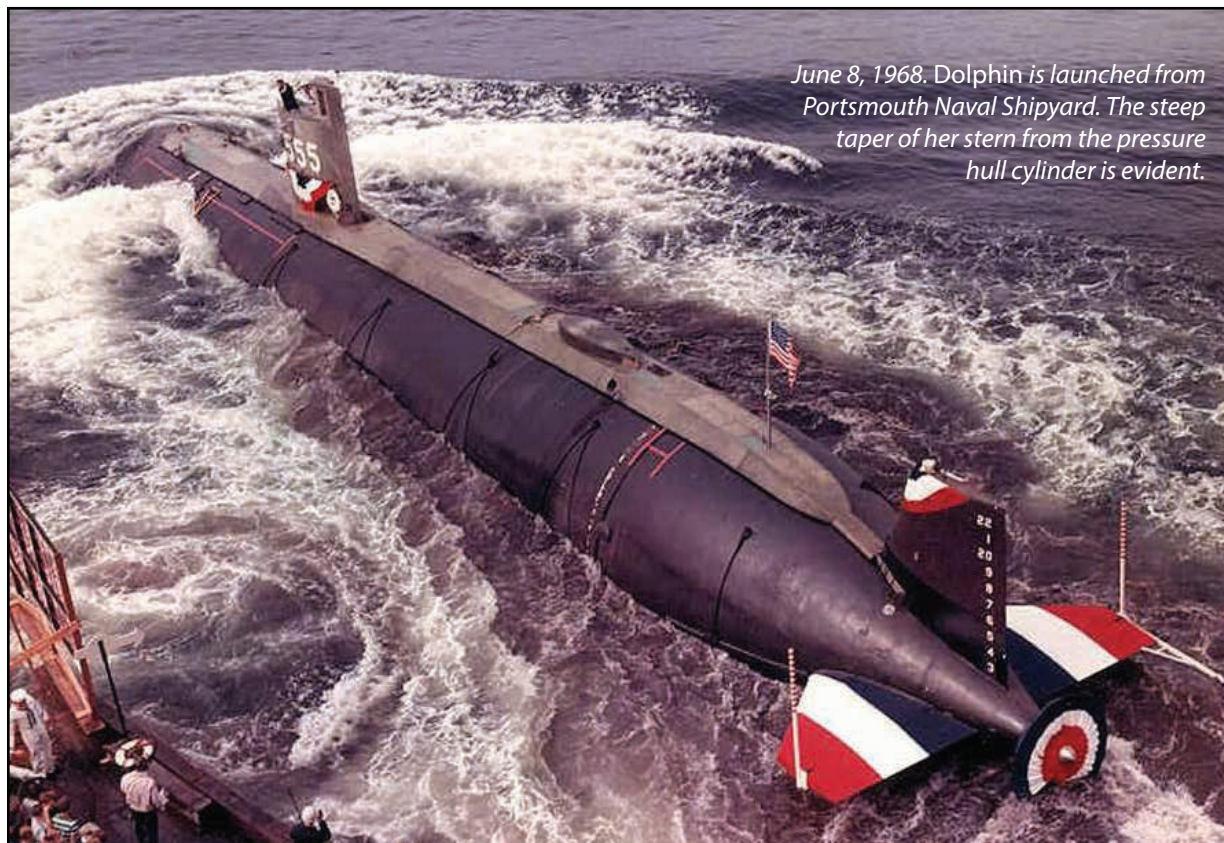
June 8, 1968. Dolphin is launched from Portsmouth Naval Shipyard. The steep taper of her stern from the pressure hull cylinder is evident.

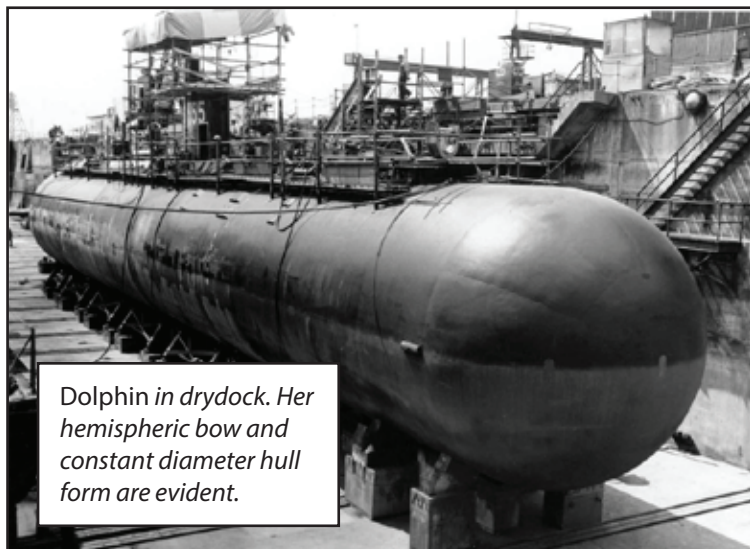
Dolphin in drydock. Her hemispheric bow and constant diameter hull form are evident.

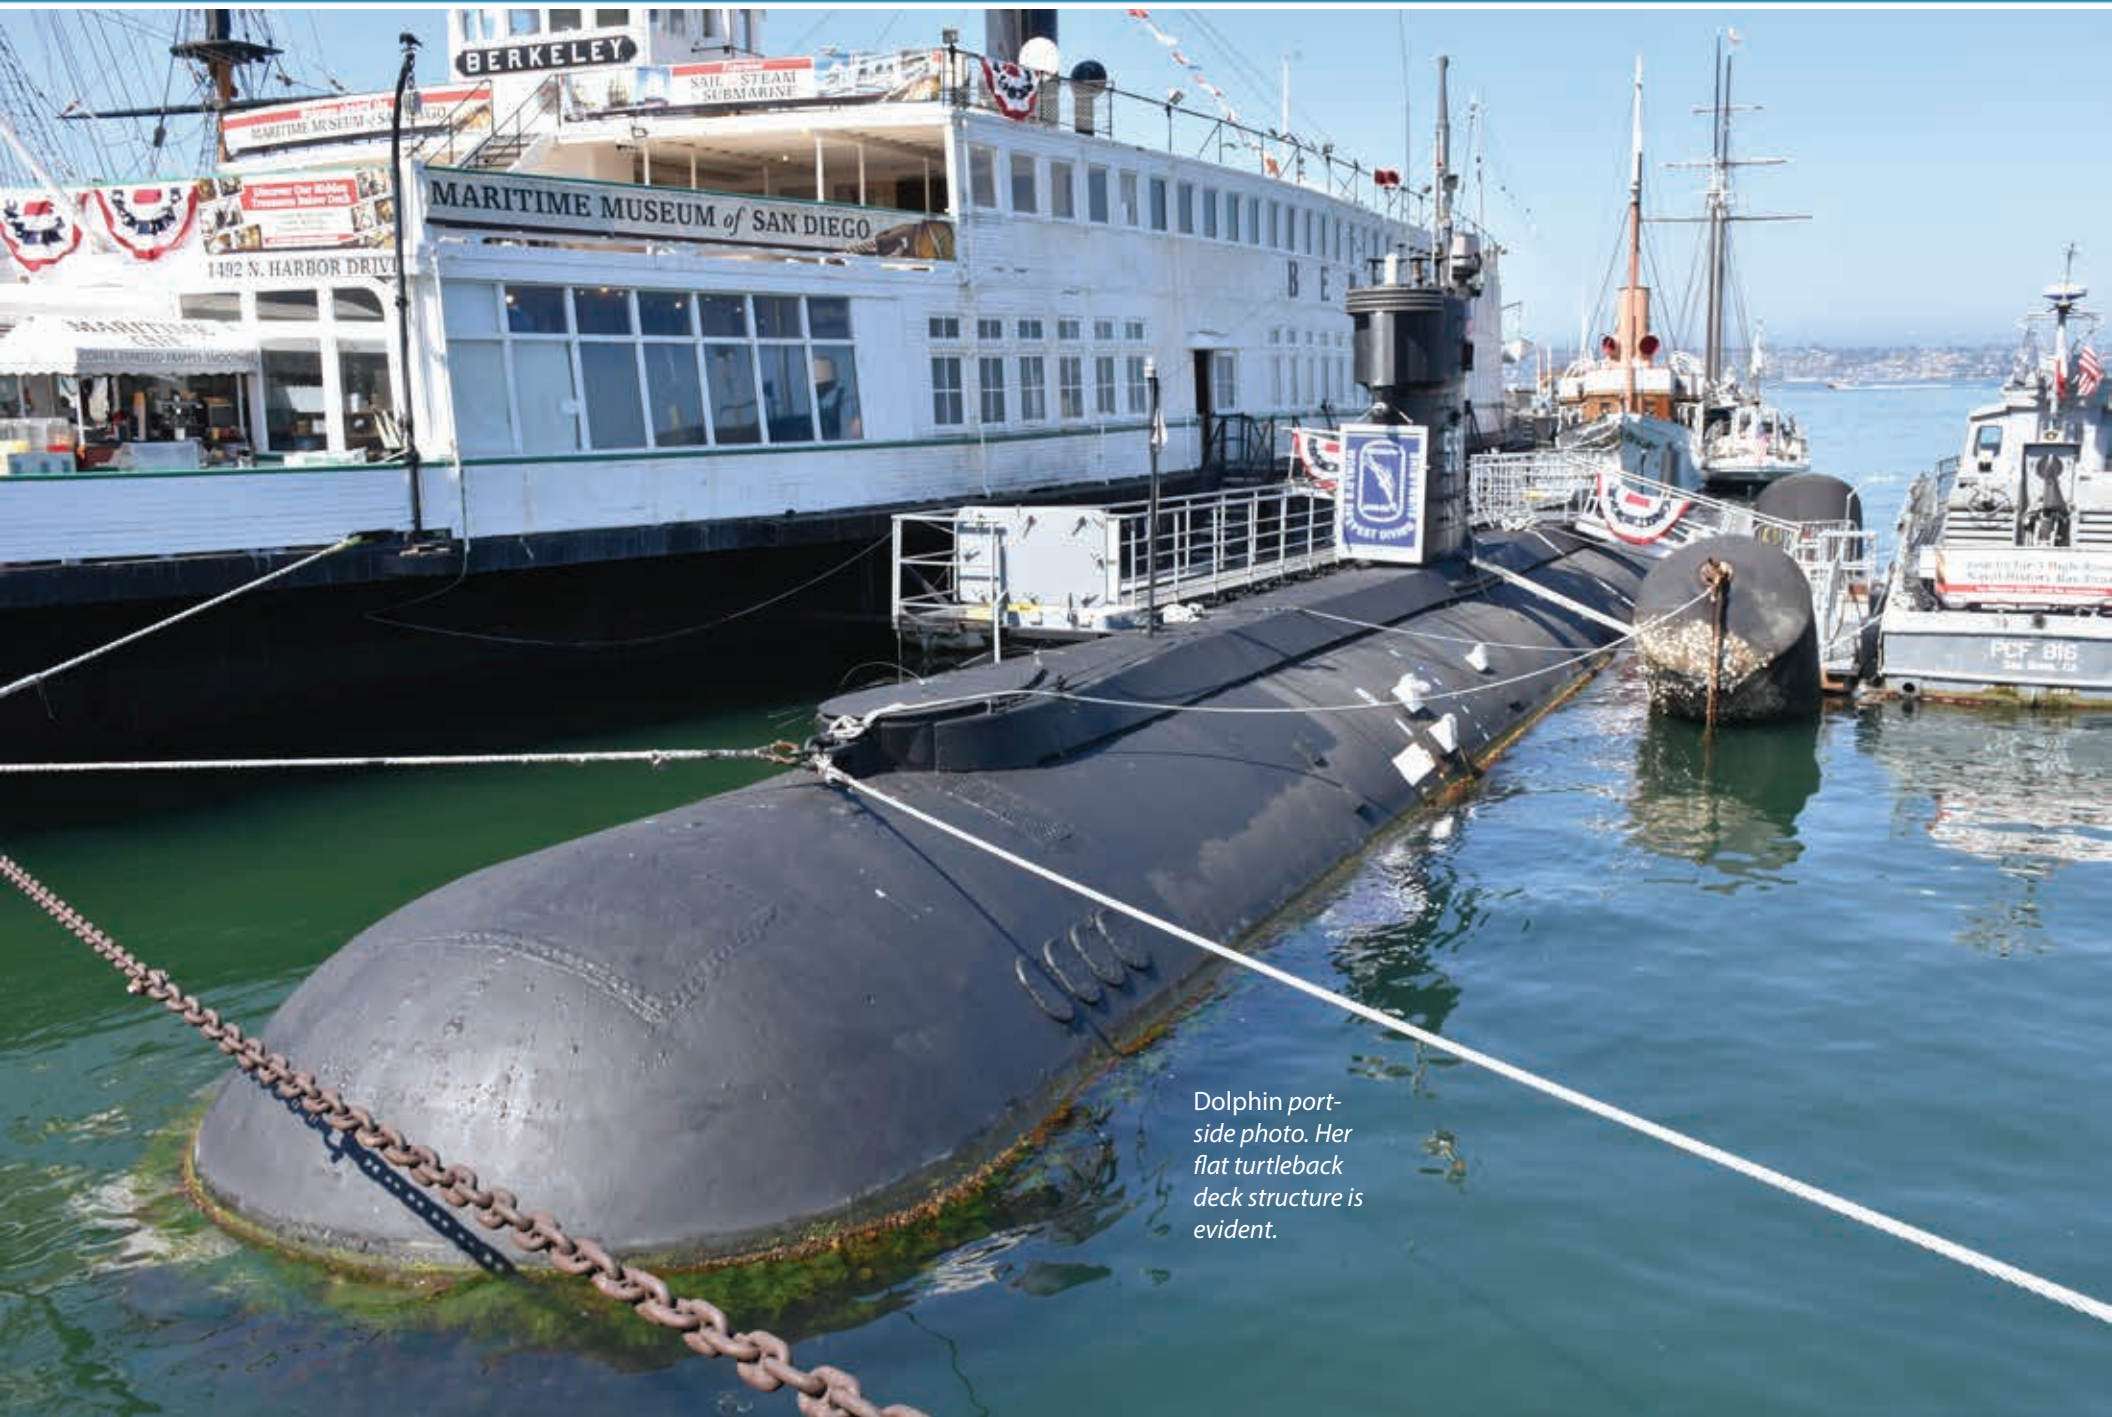
Dolphin port-side photo. Her flat turtleback deck structure is evident.

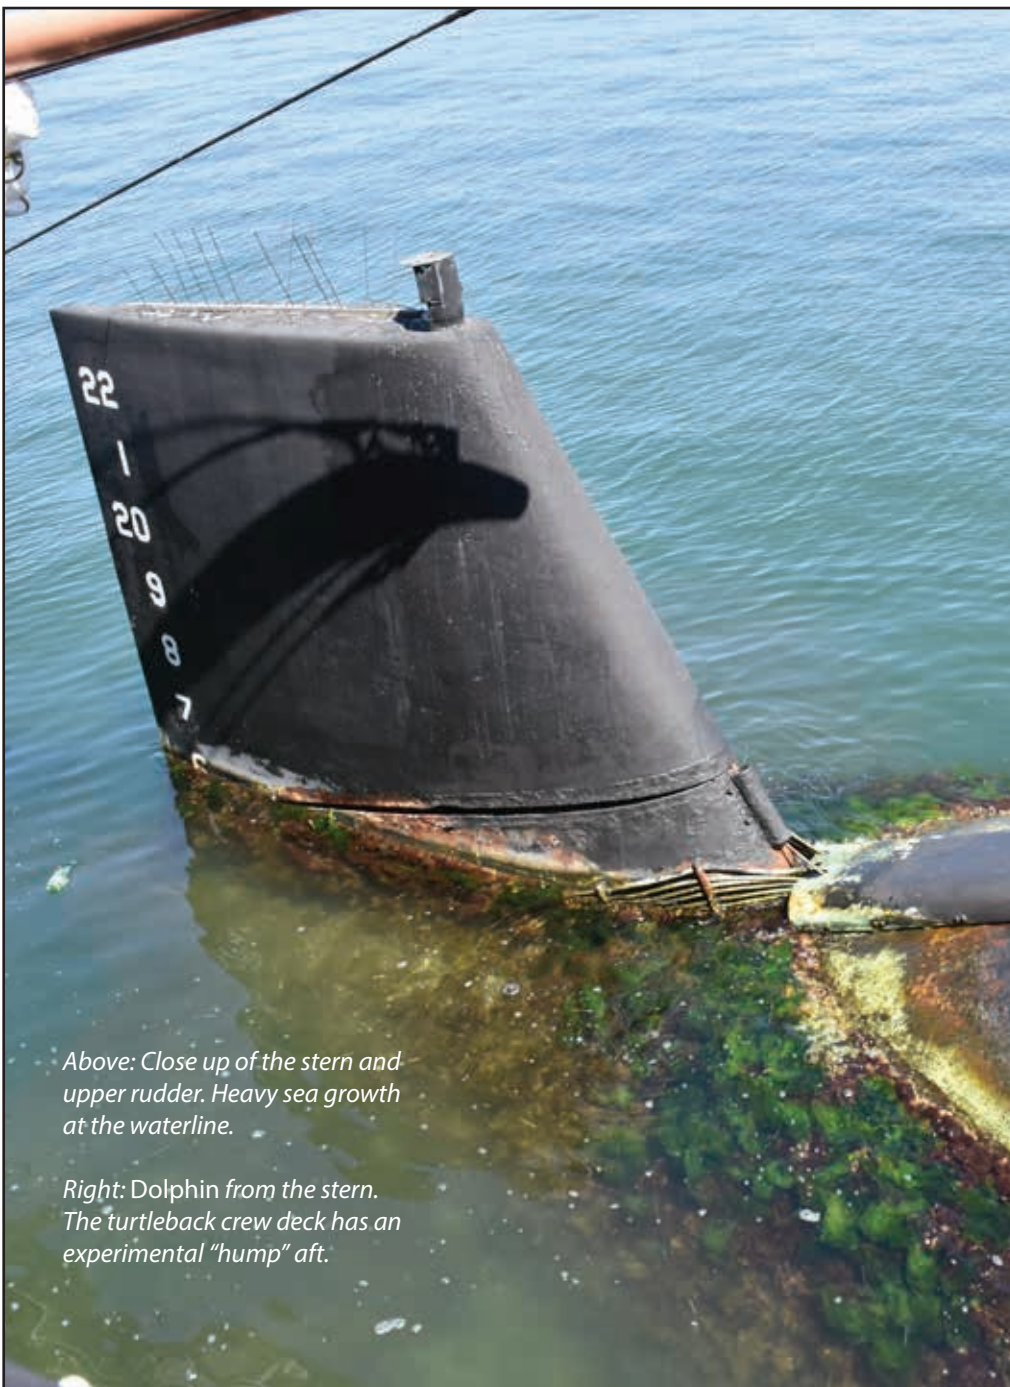
Above: Close up of the stern and upper rudder. Heavy sea growth at the waterline.

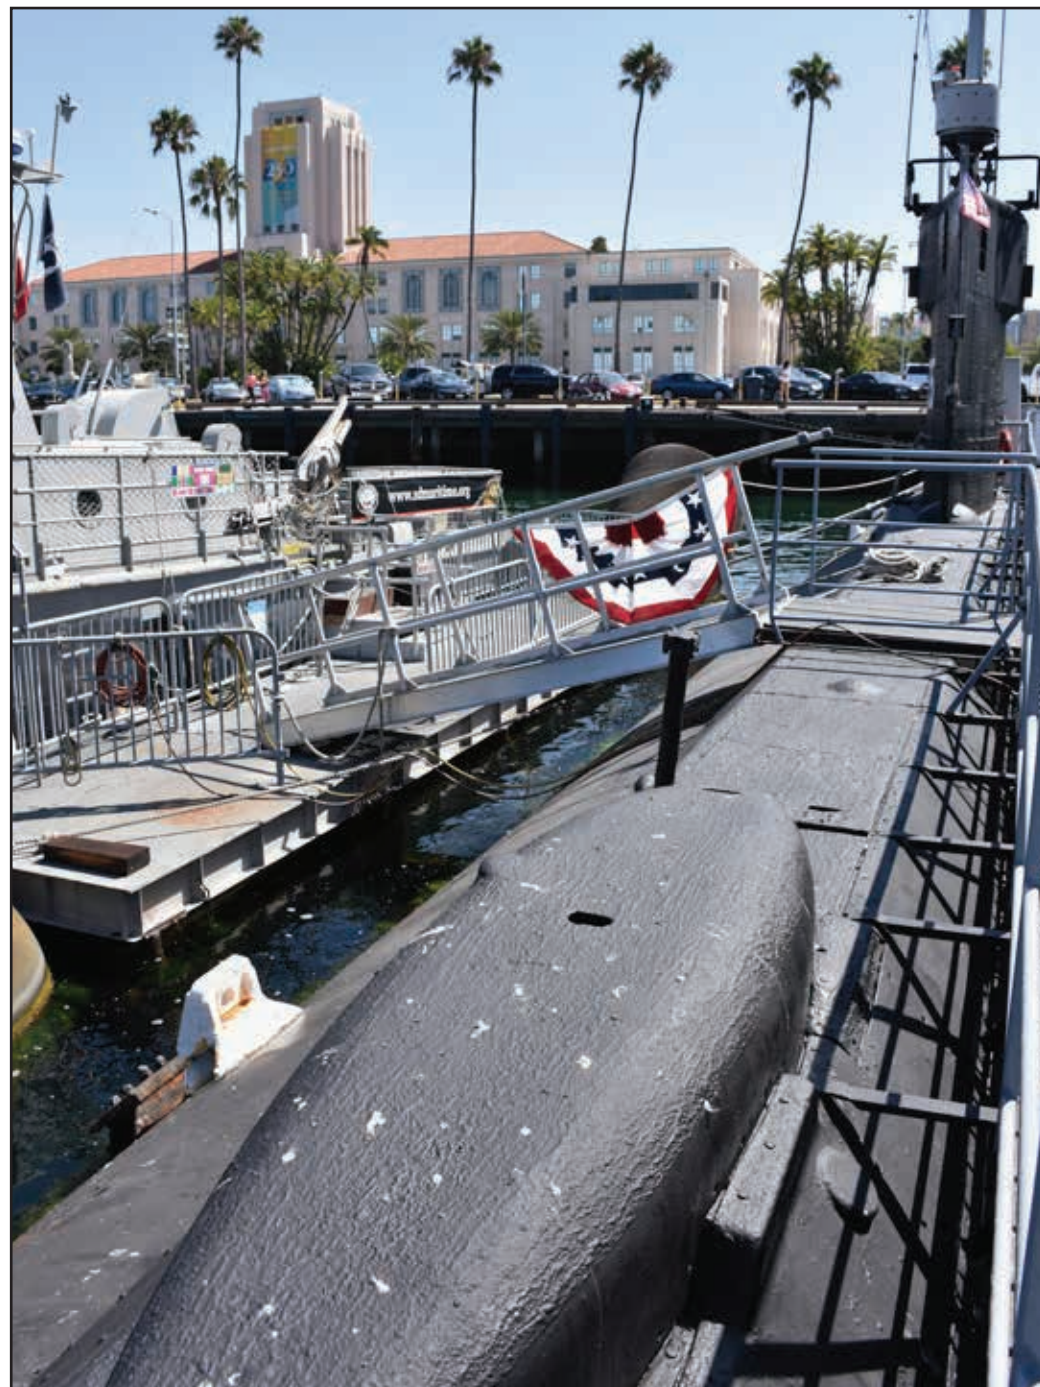
Right: Dolphin from the stern. The turtleback crew deck has an experimental "hump" aft.

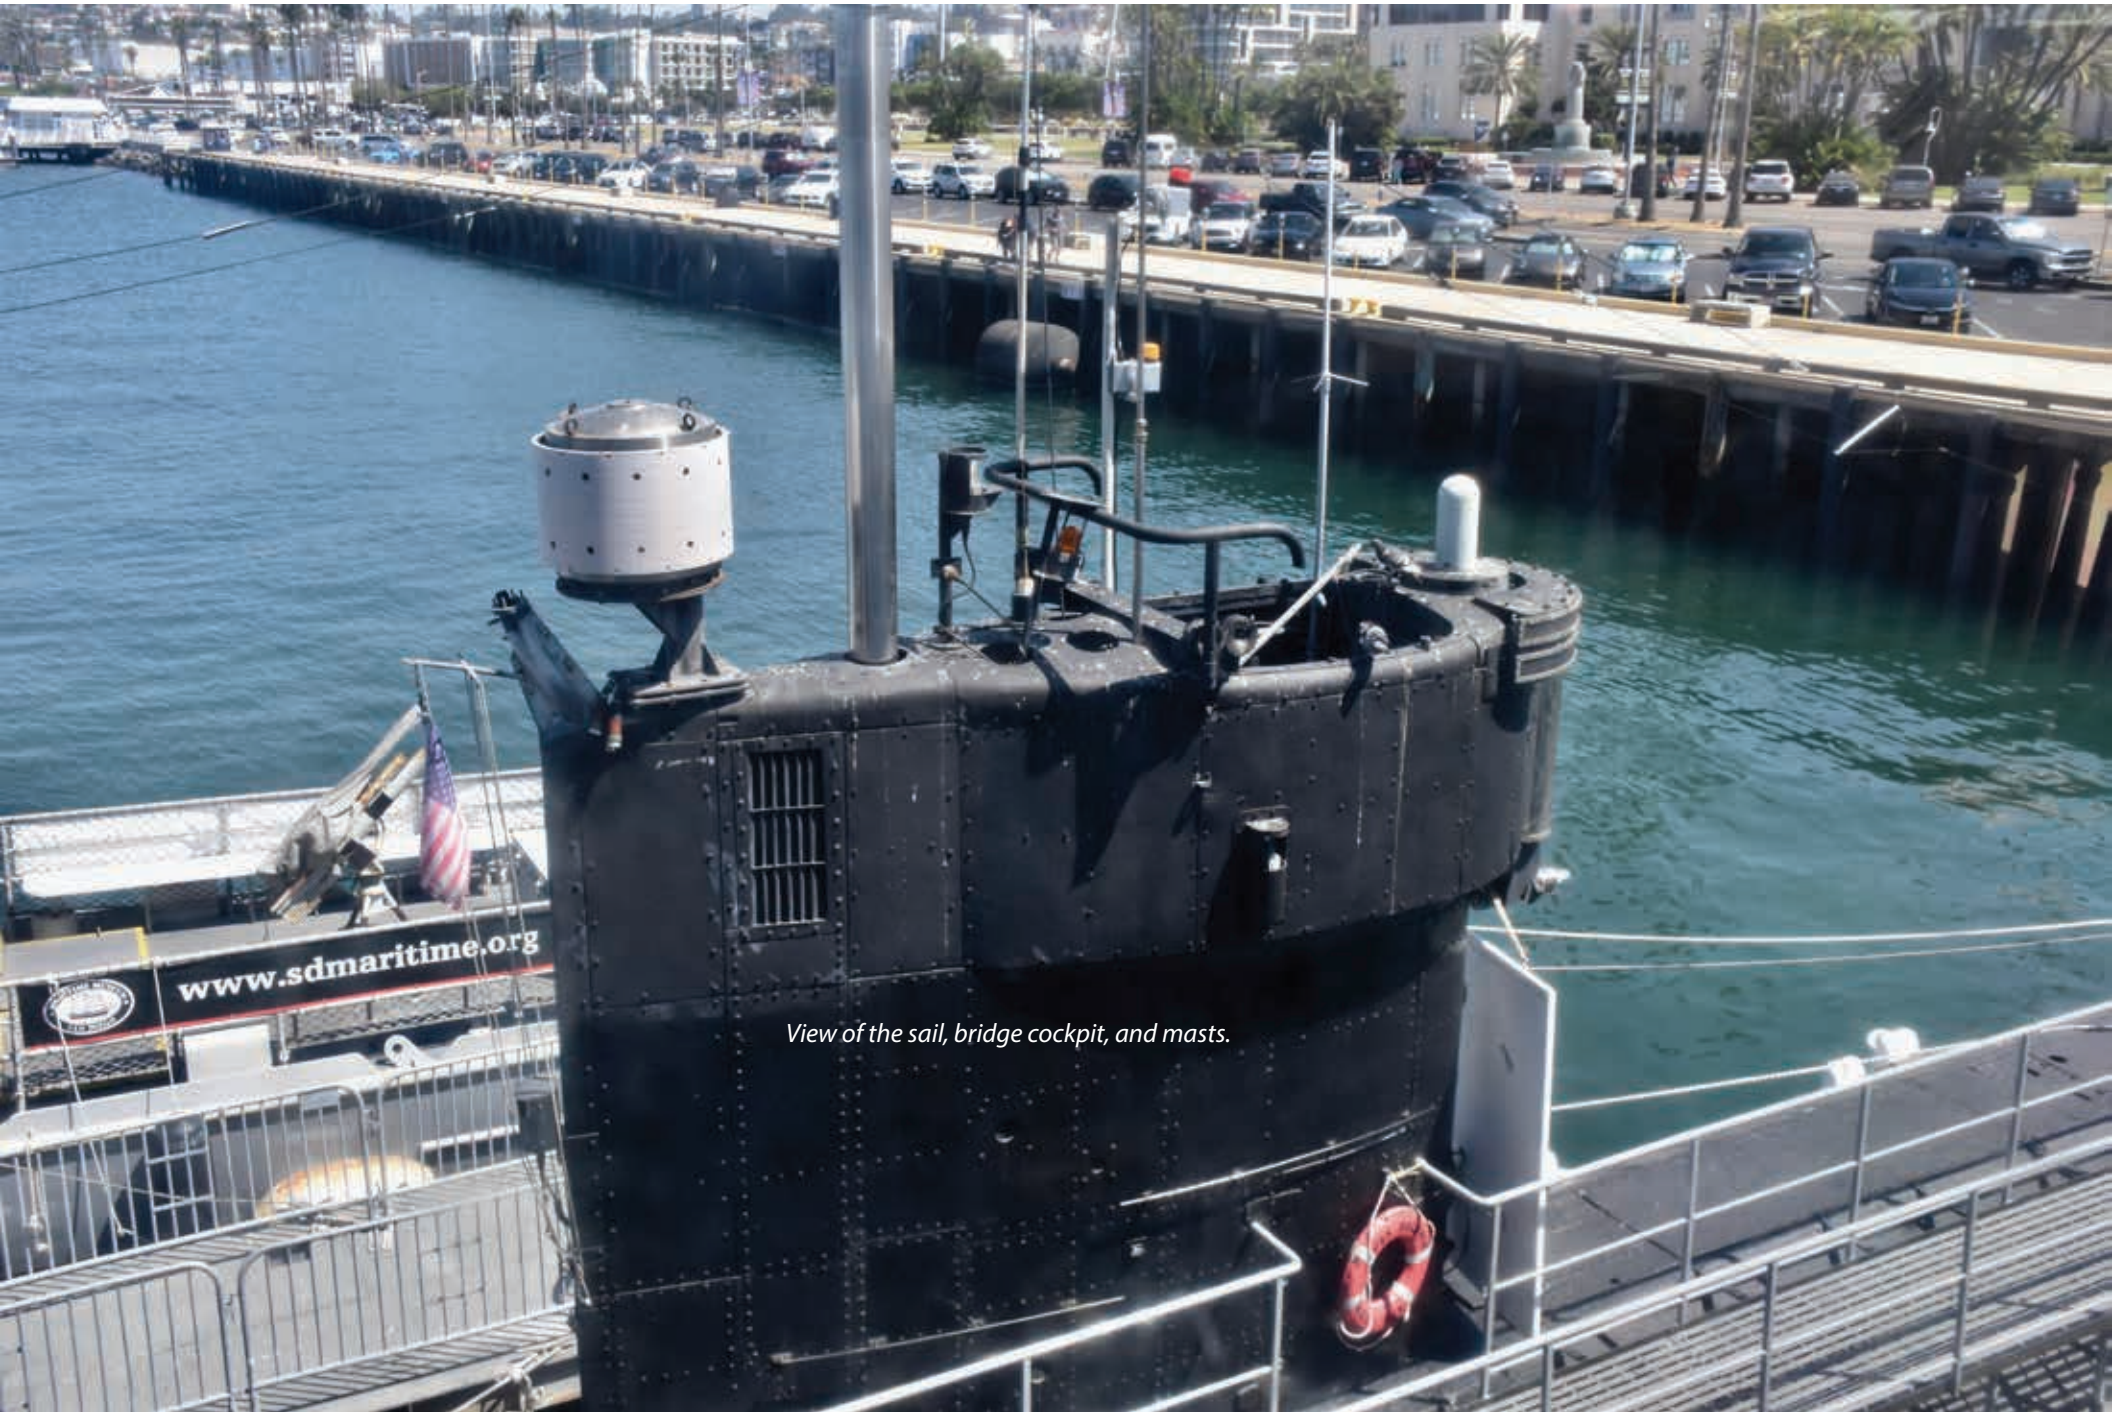
View of the sail, bridge cockpit, and masts.

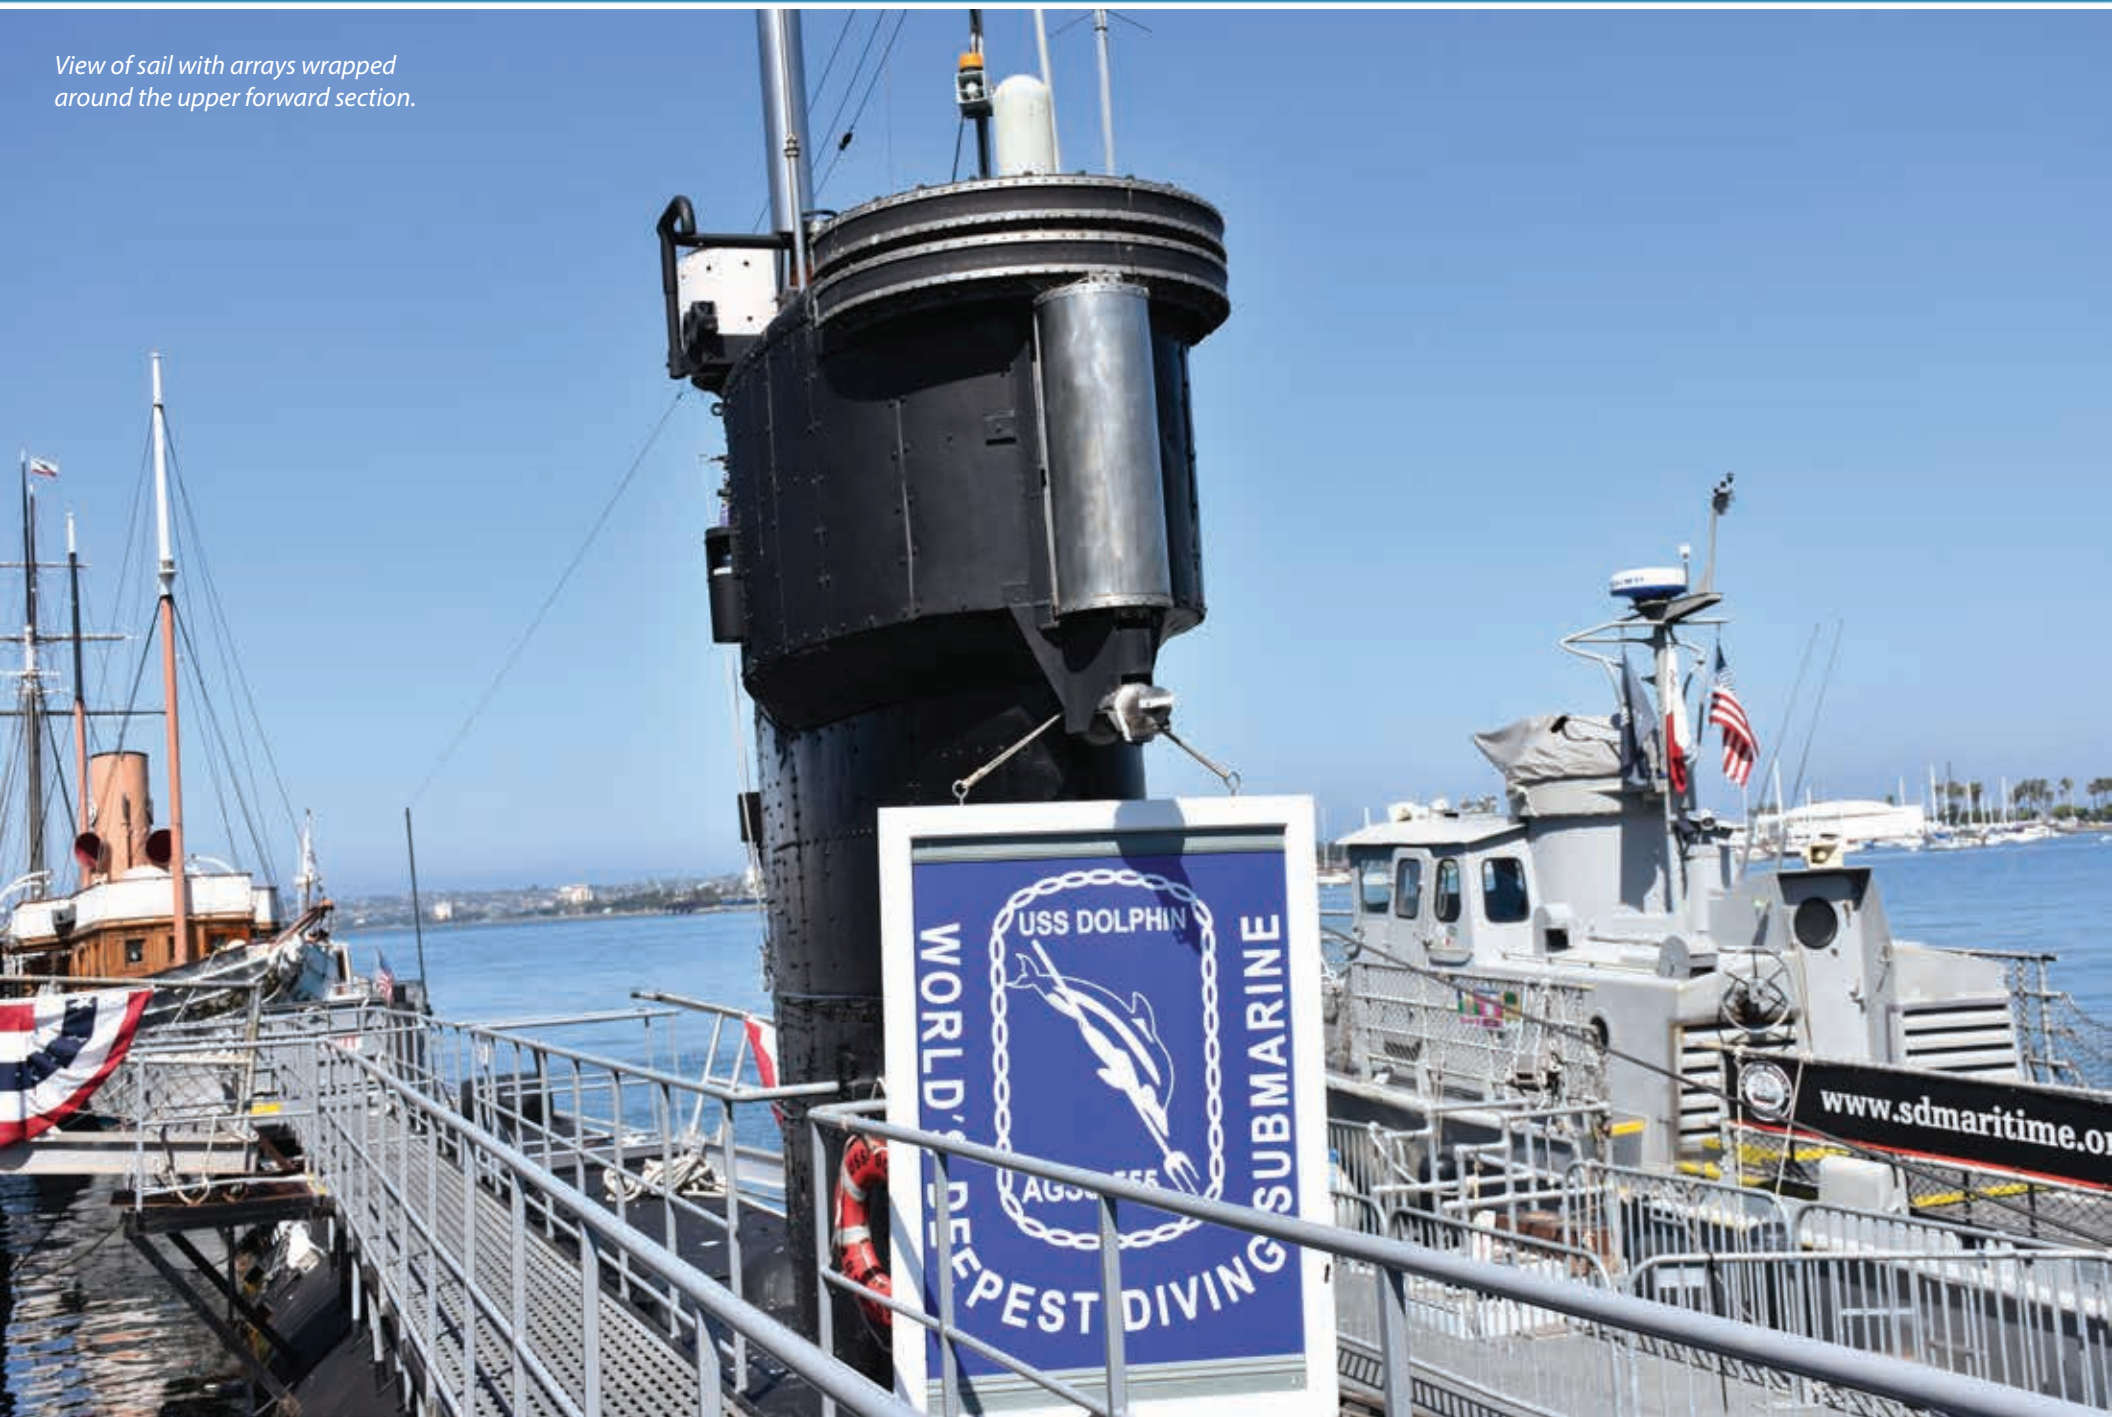
View of sail with arrays wrapped around the upper forward section.

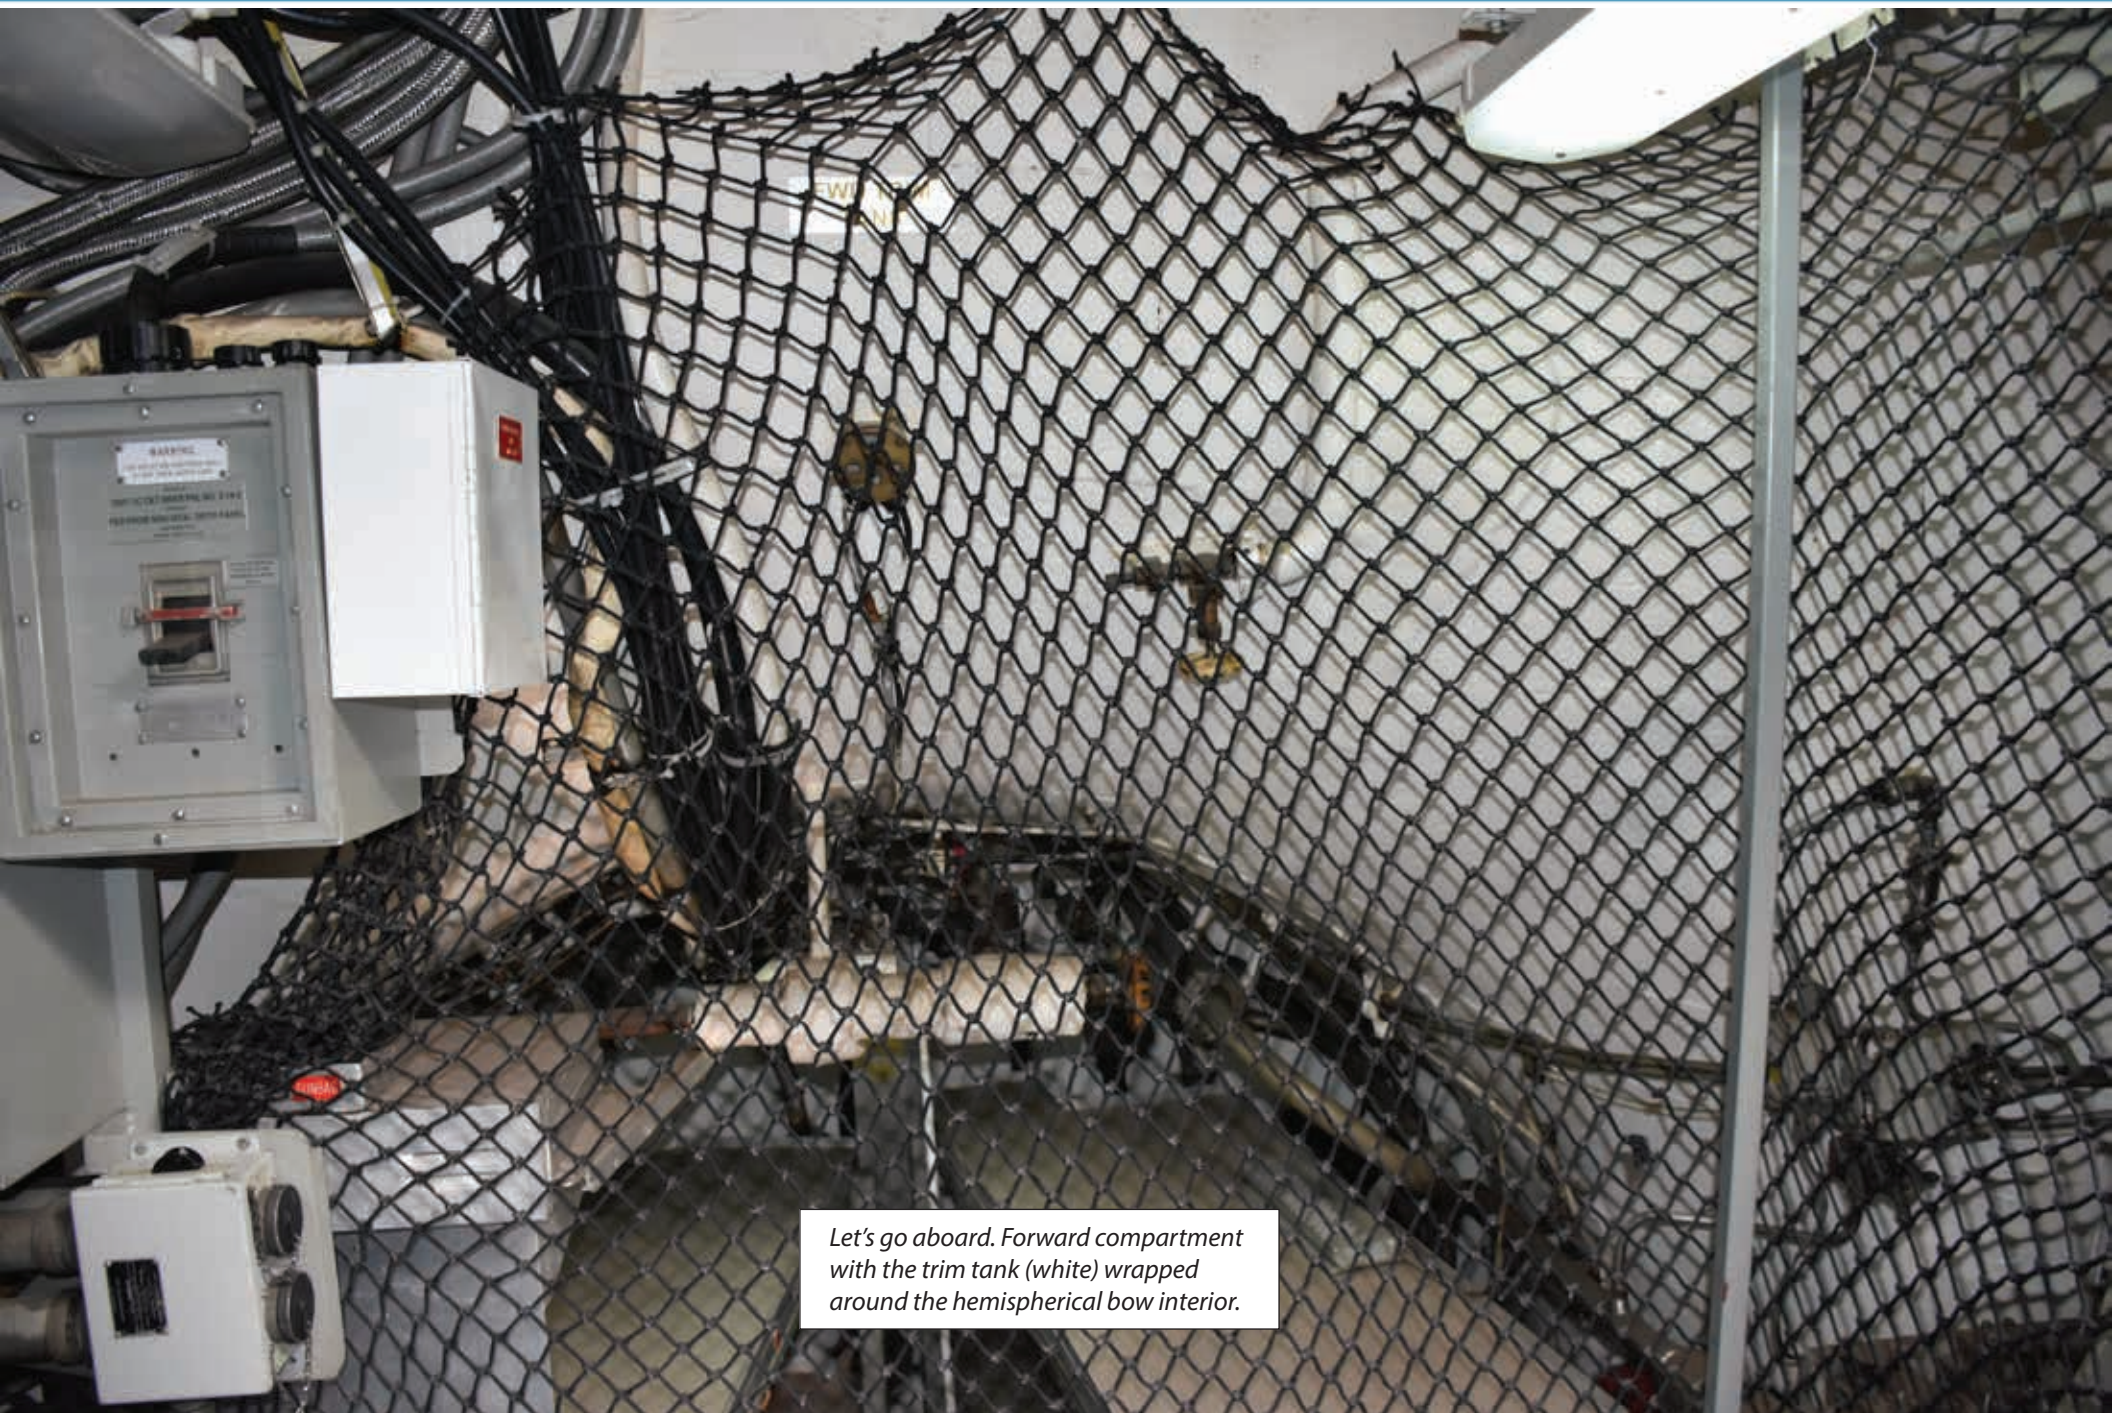
Let's go aboard. Forward compartment with the trim tank (white) wrapped around the hemispherical bow interior.

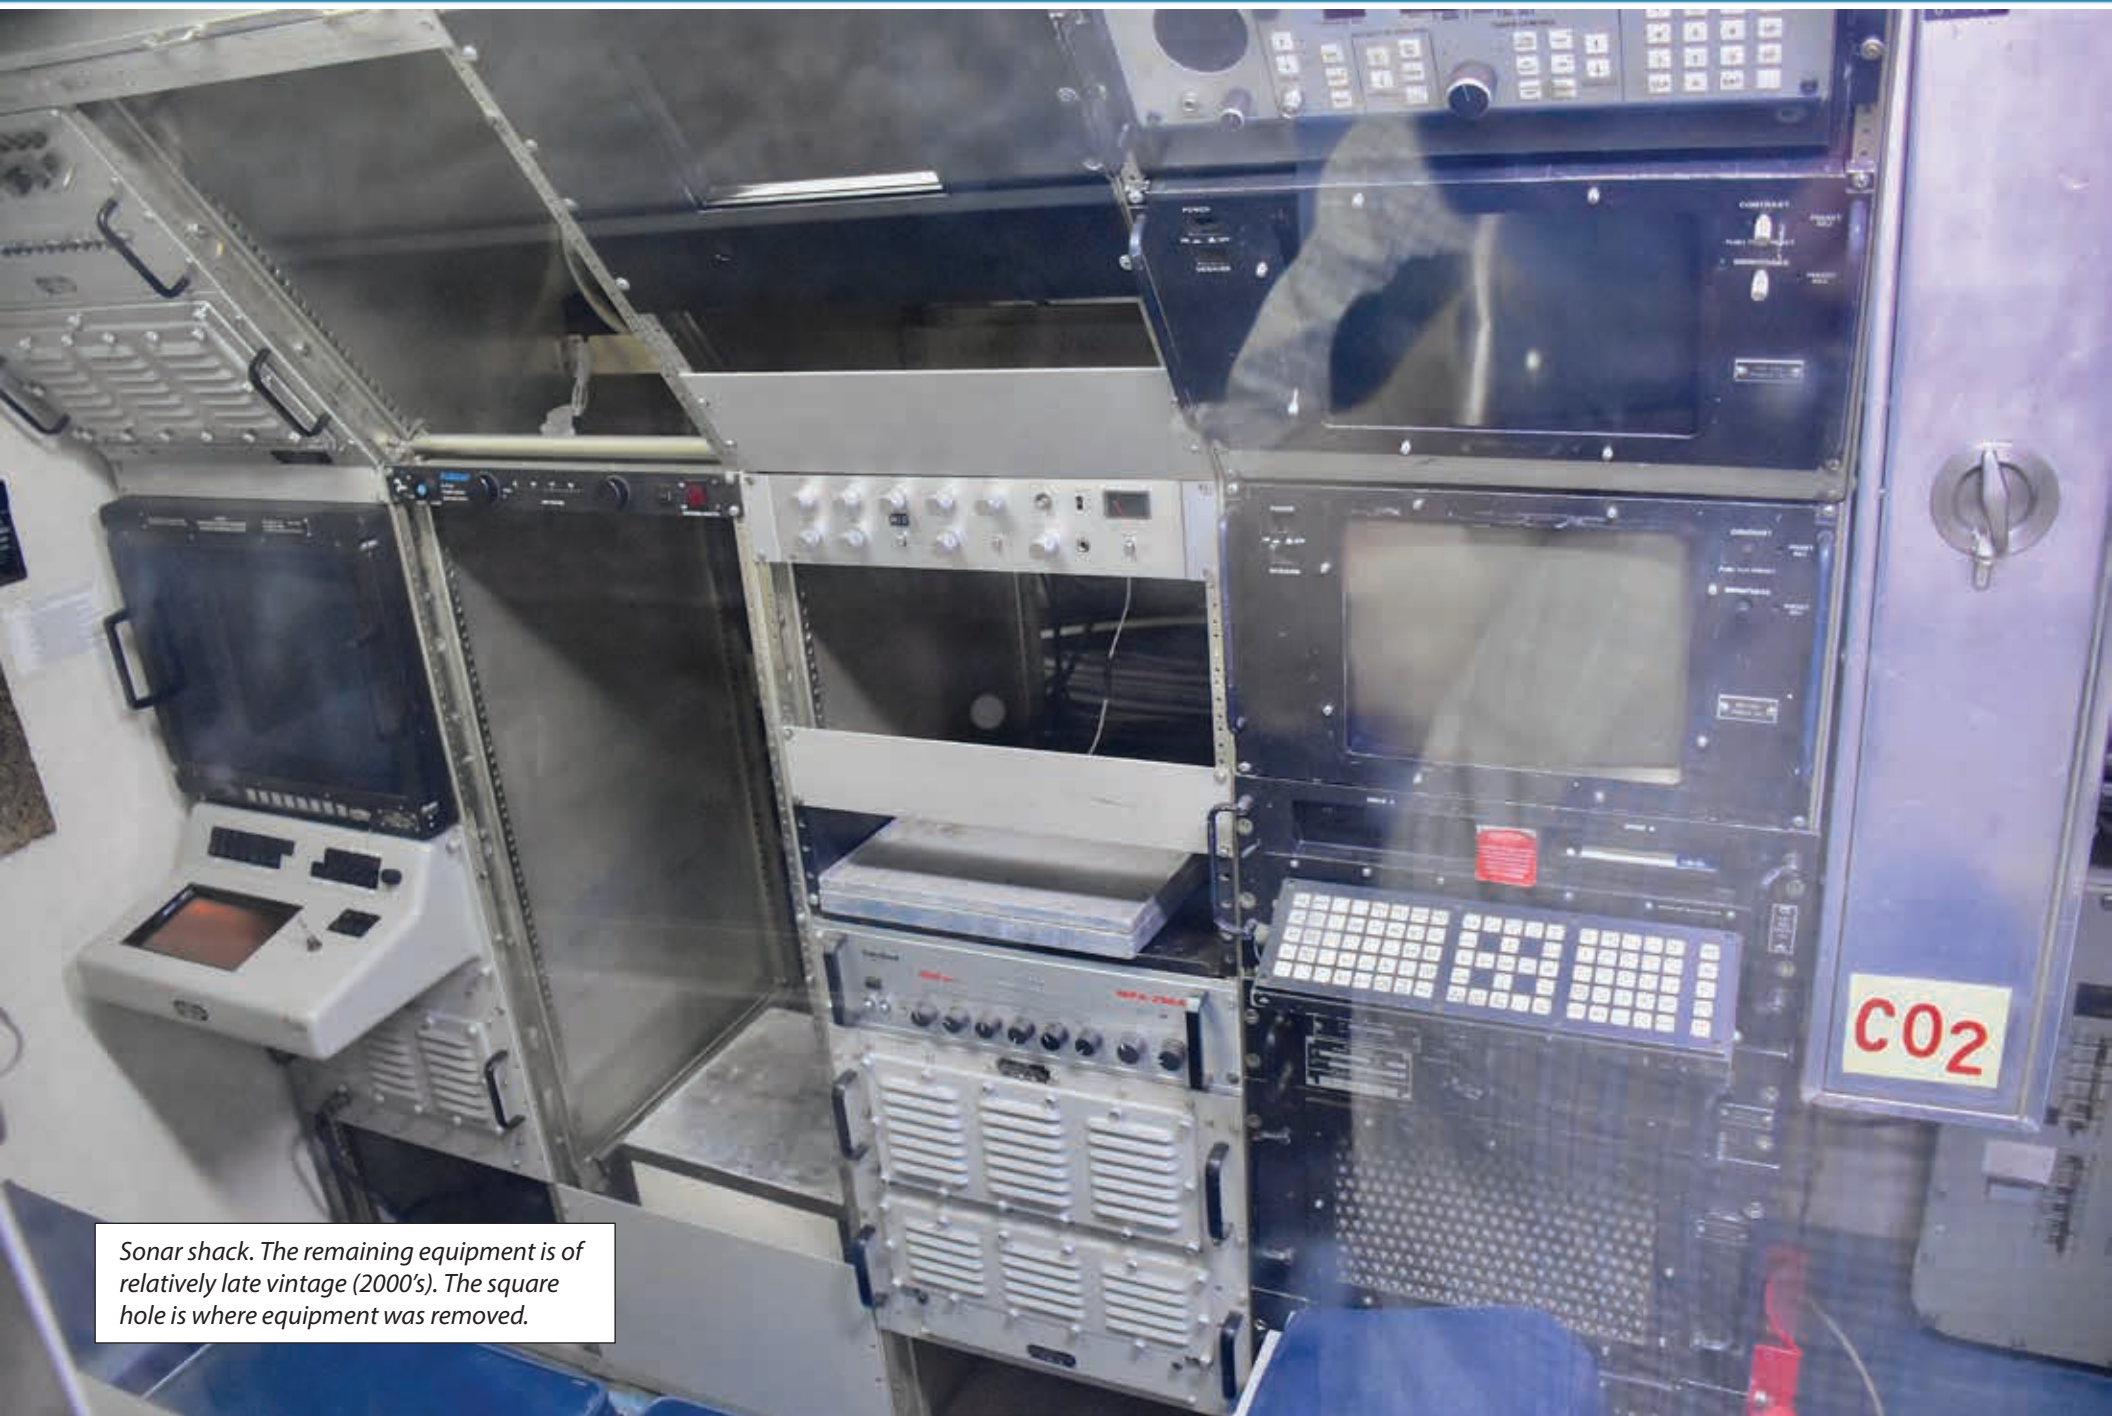
Sonar shack. The remaining equipment is of relatively late vintage (2000's). The square hole is where equipment was removed.

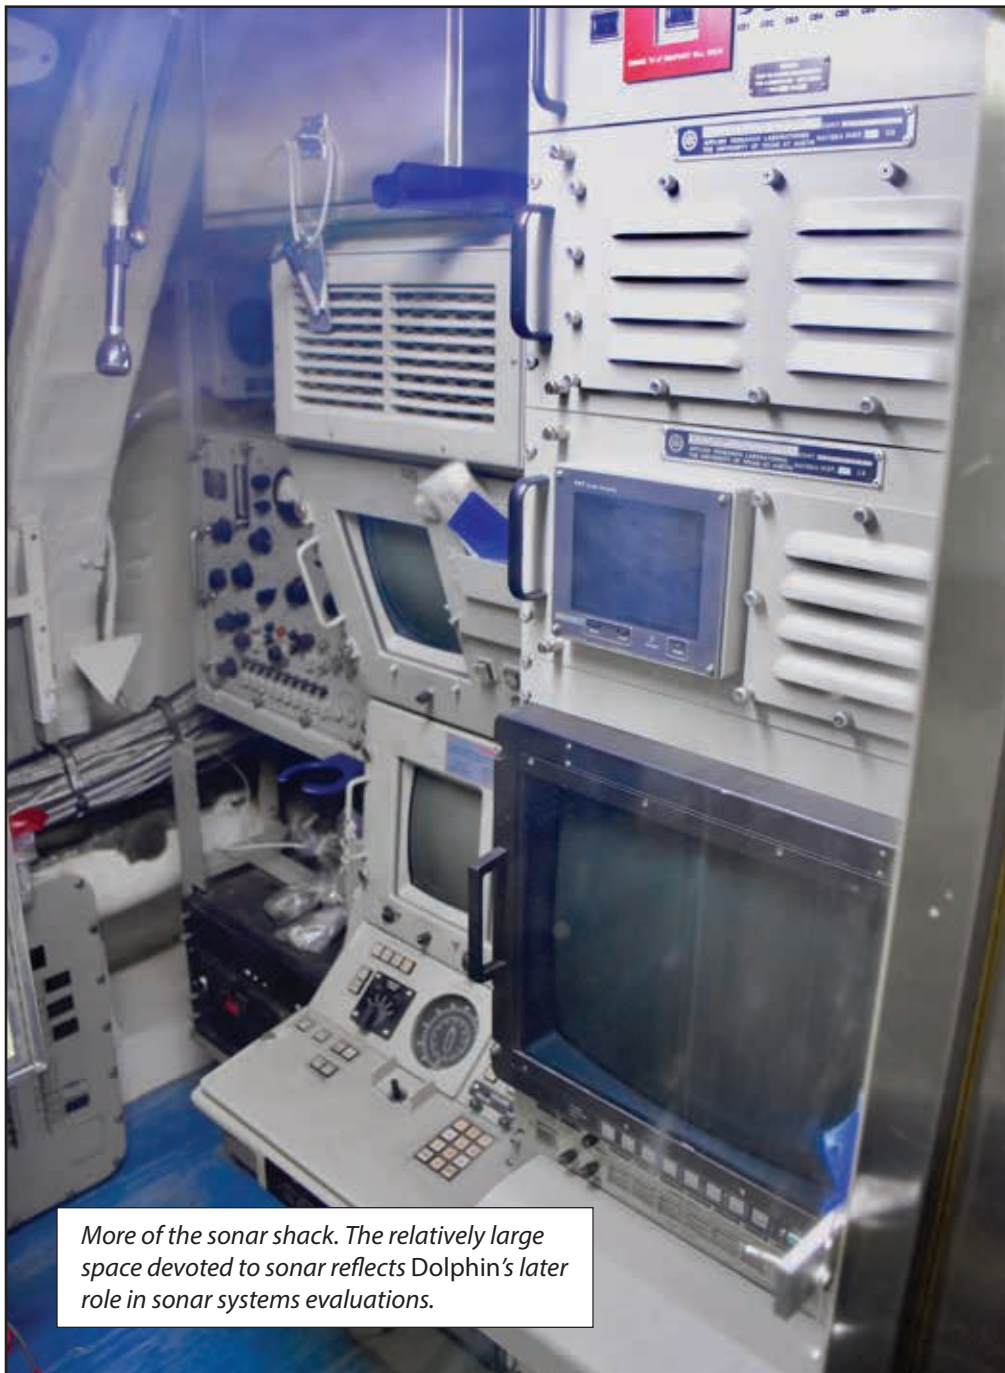
More of the sonar shack. The relatively large space devoted to sonar reflects Dolphin's later role in sonar systems evaluations.
