by Tom Dougherty

USS *Dolphin* (AGSS-555) - The "Triple Nickel" - The Last U.S. Diesel Submarine

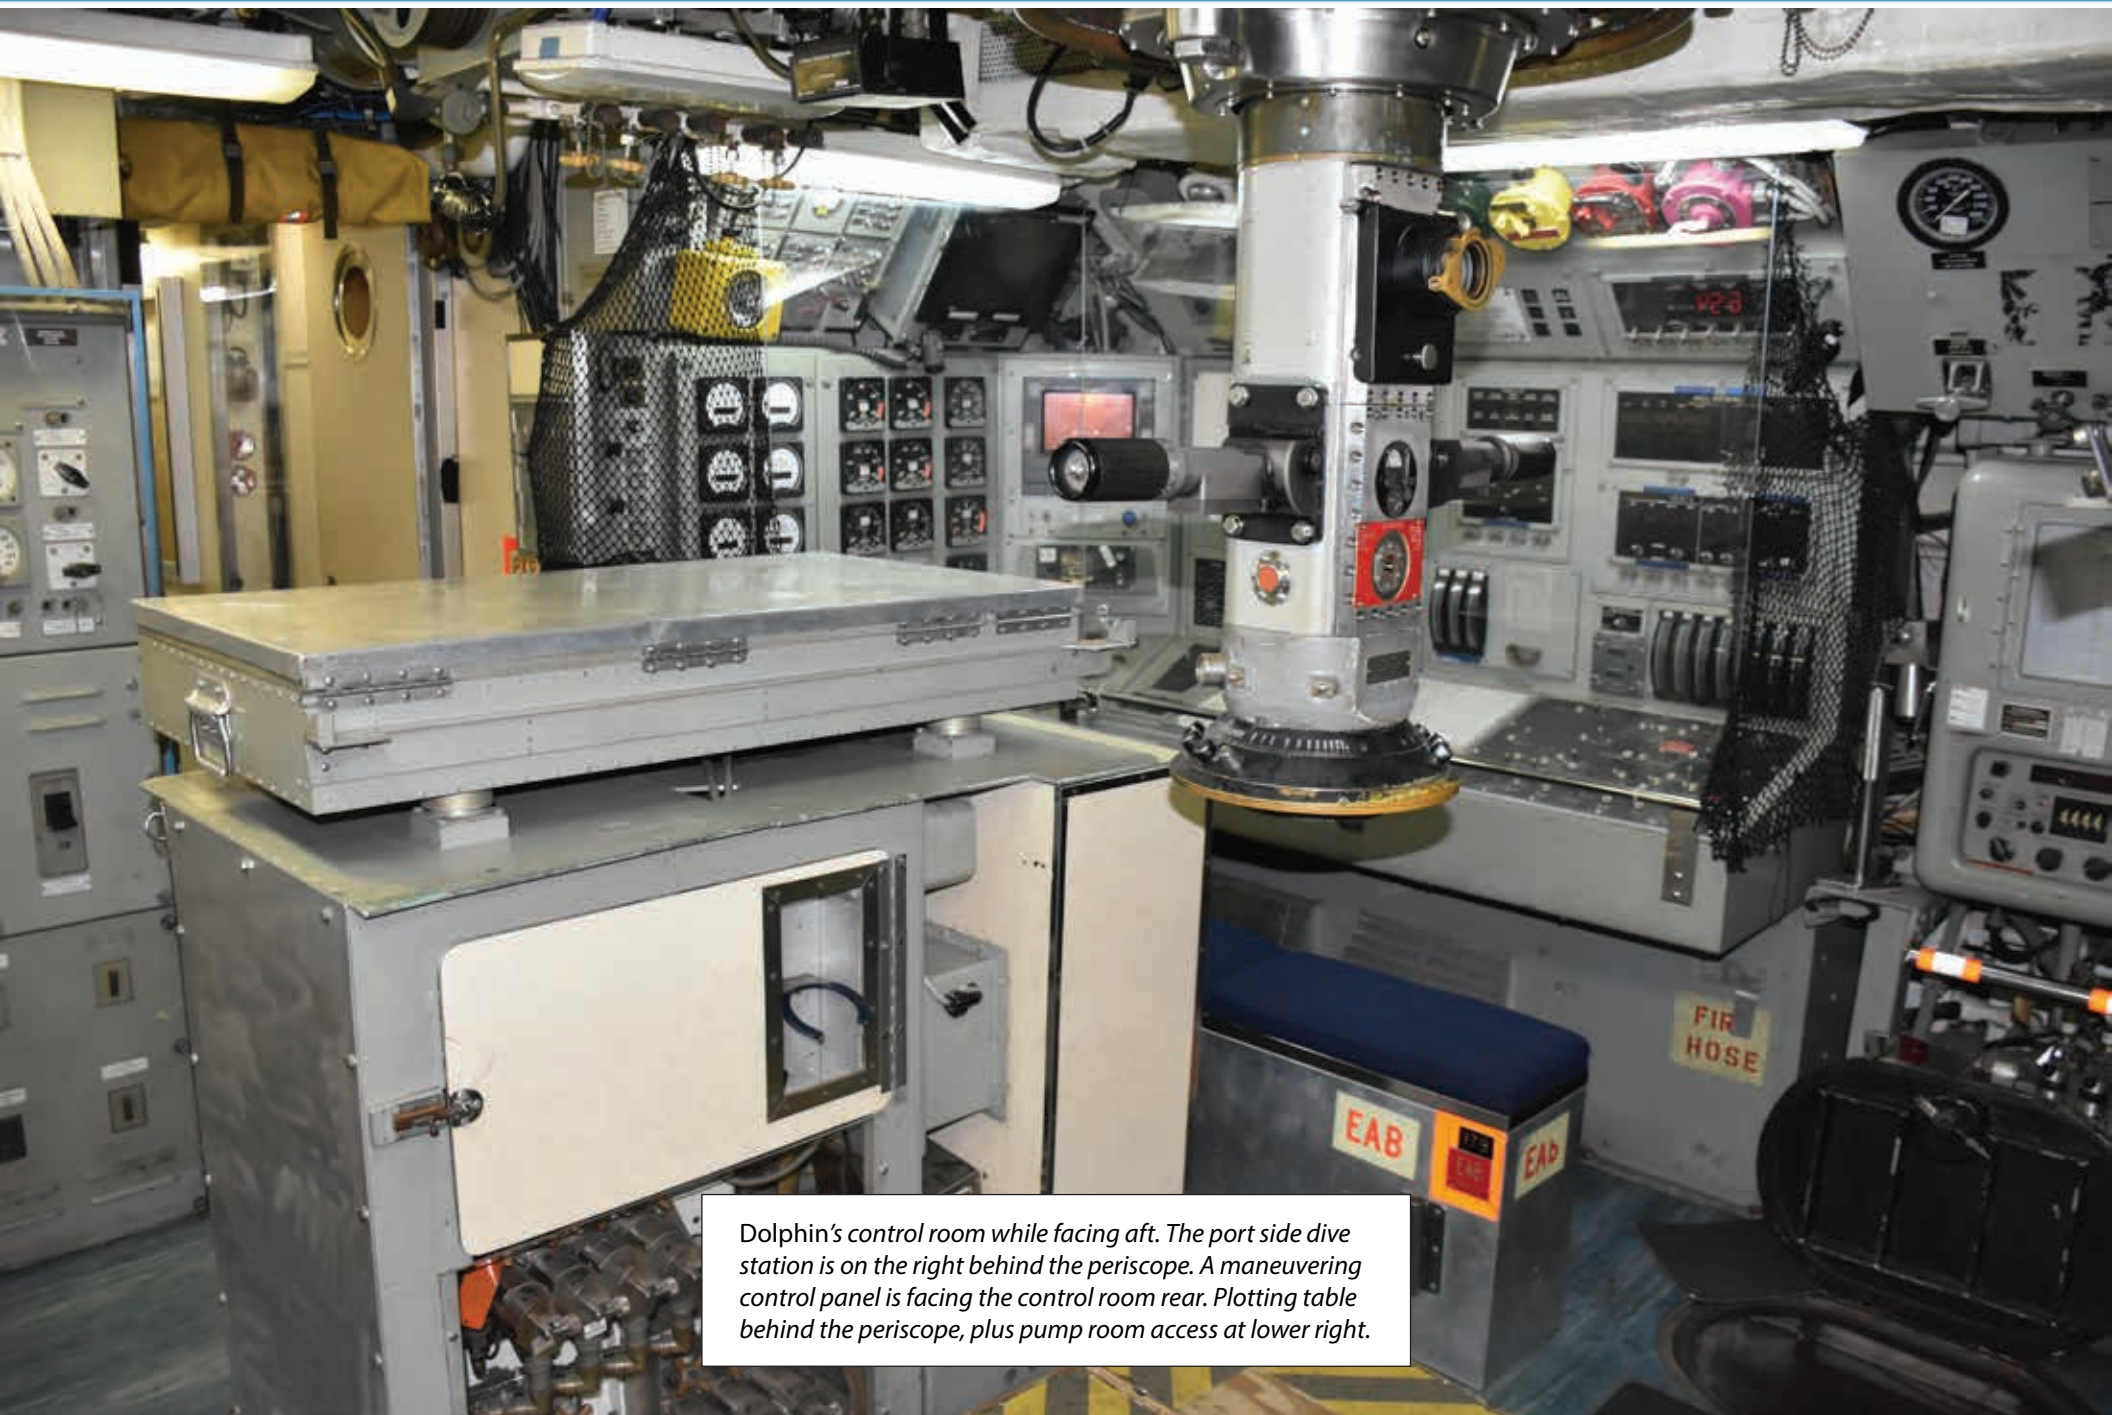
Dolphin's control room while facing aft. The port side dive station is on the right behind the periscope. A maneuvering control panel is facing the control room rear. Plotting table behind the periscope, plus pump room access at lower right.

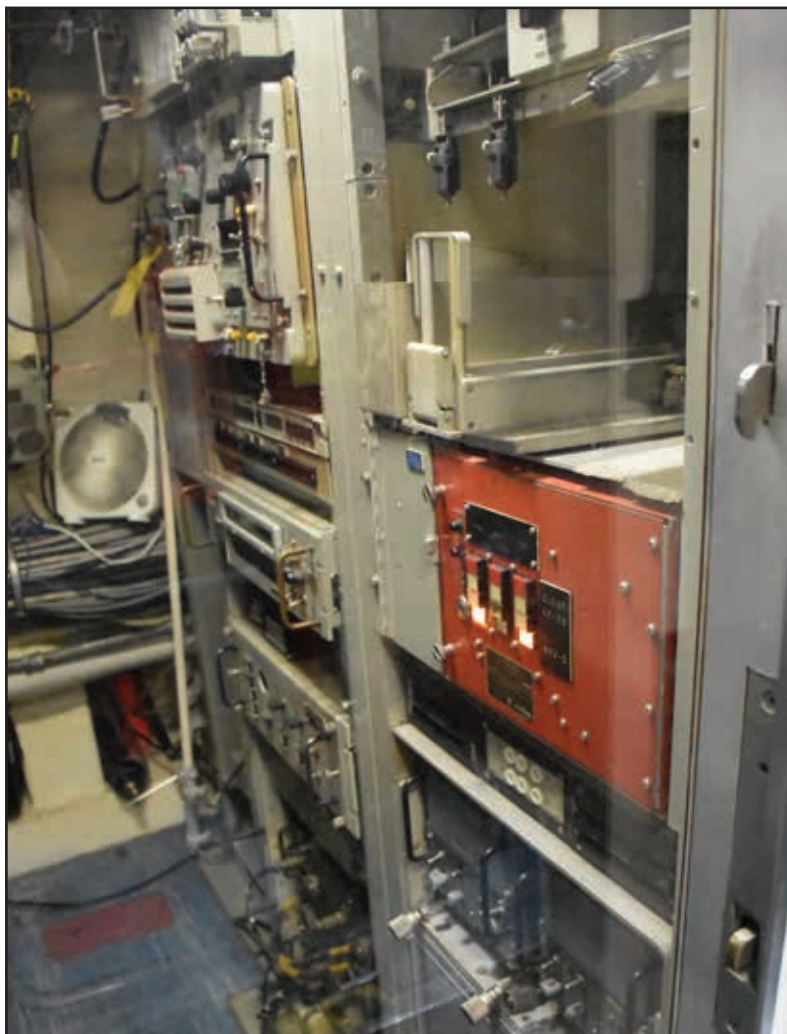
Above: The radio shack. Racks allowed equipment to be swapped in and out for tests.

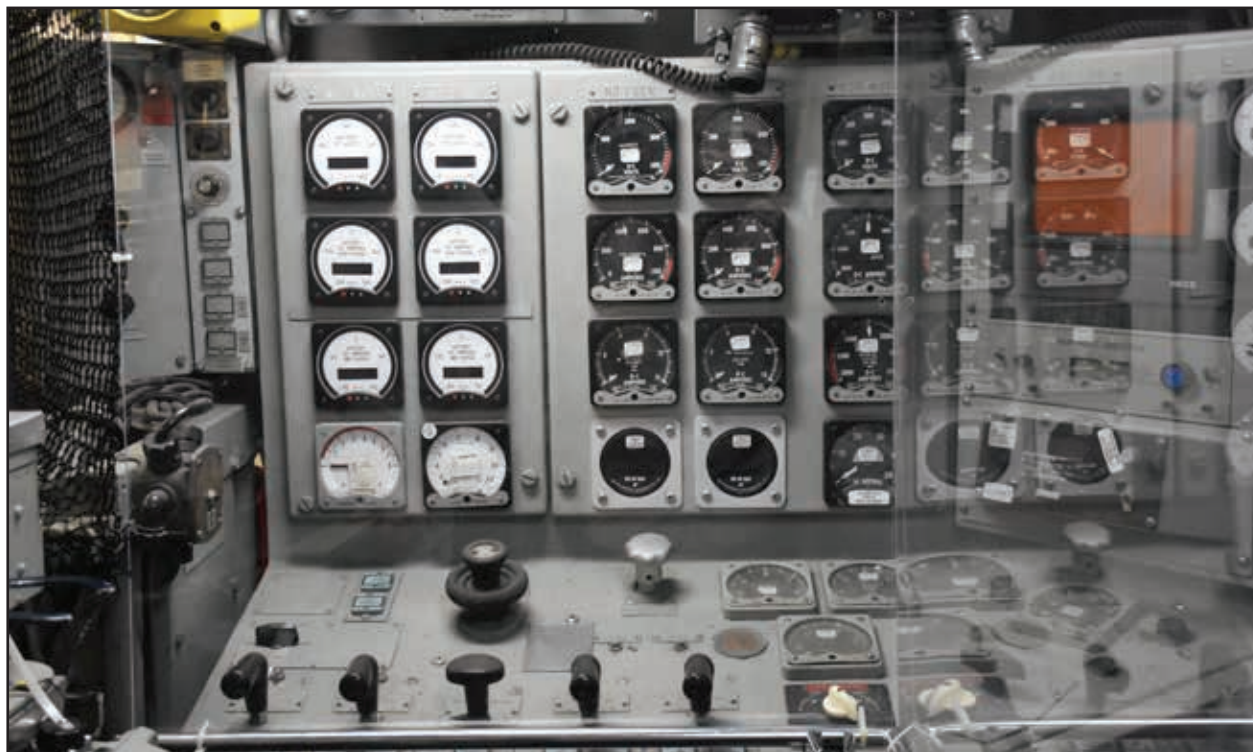
Top right: At a right angle to the dive station in the control compartment rear are many of the controls found in a traditional submarine maneuvering room. Amps, volts, generator and battery status gauges, among others.

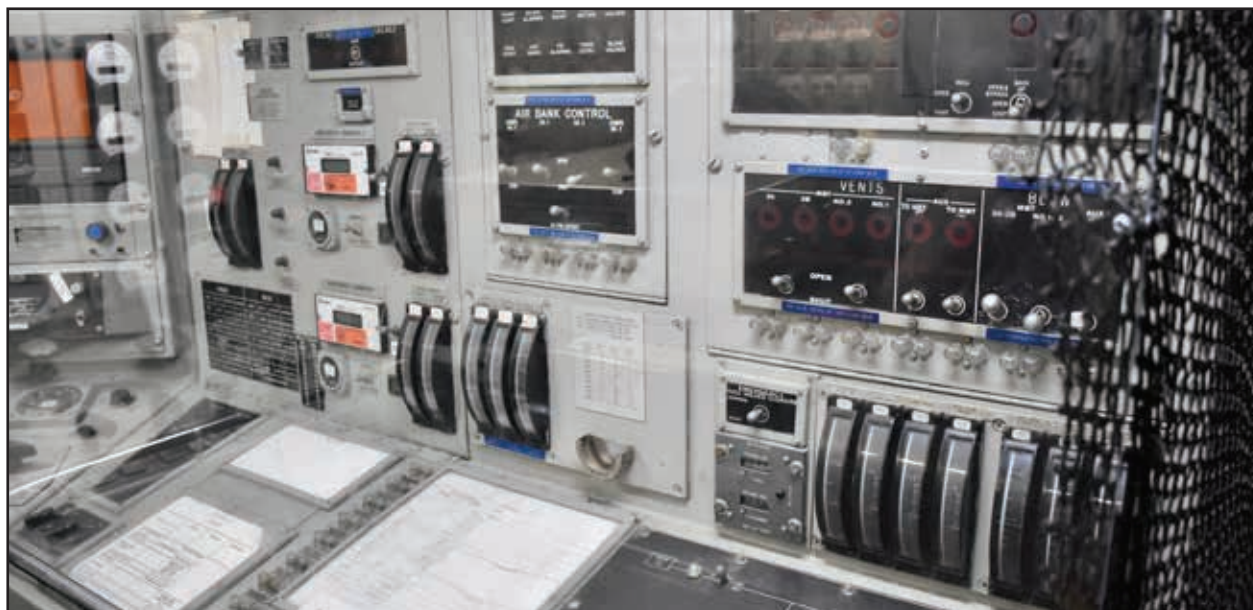
Lower right: Closeup of the ballast control panel. Hull opening indicators at top right. Vent indicators just below that.

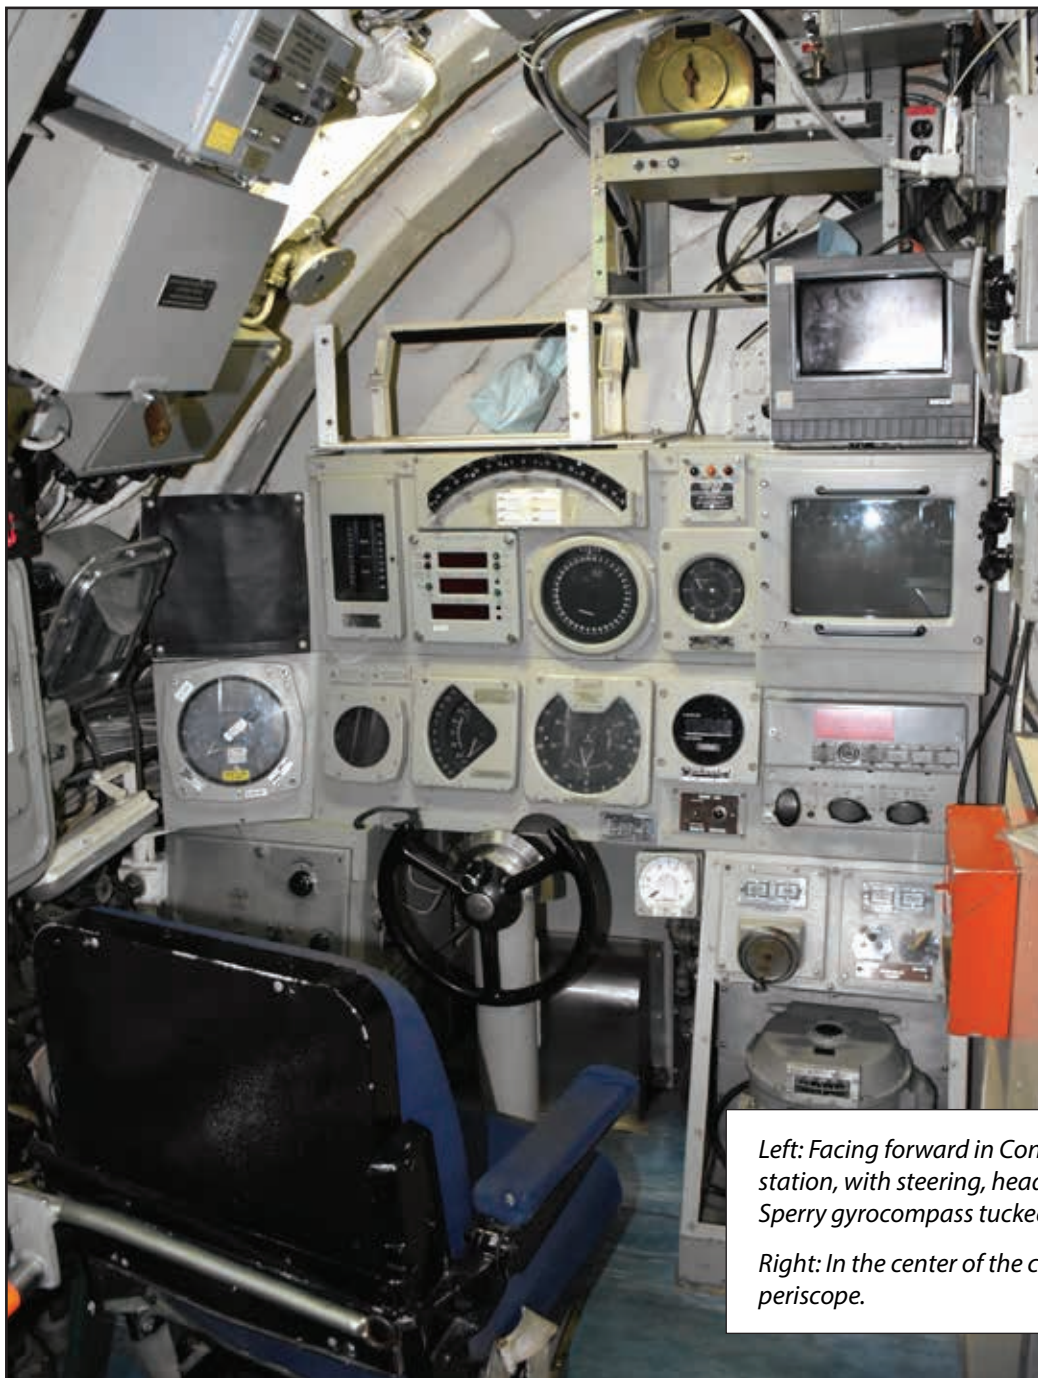
Left: Facing forward in Control, the single-pilot control station, with steering, heading, angle and depth gauges. Sperry gyrocompass tucked away at lower right.

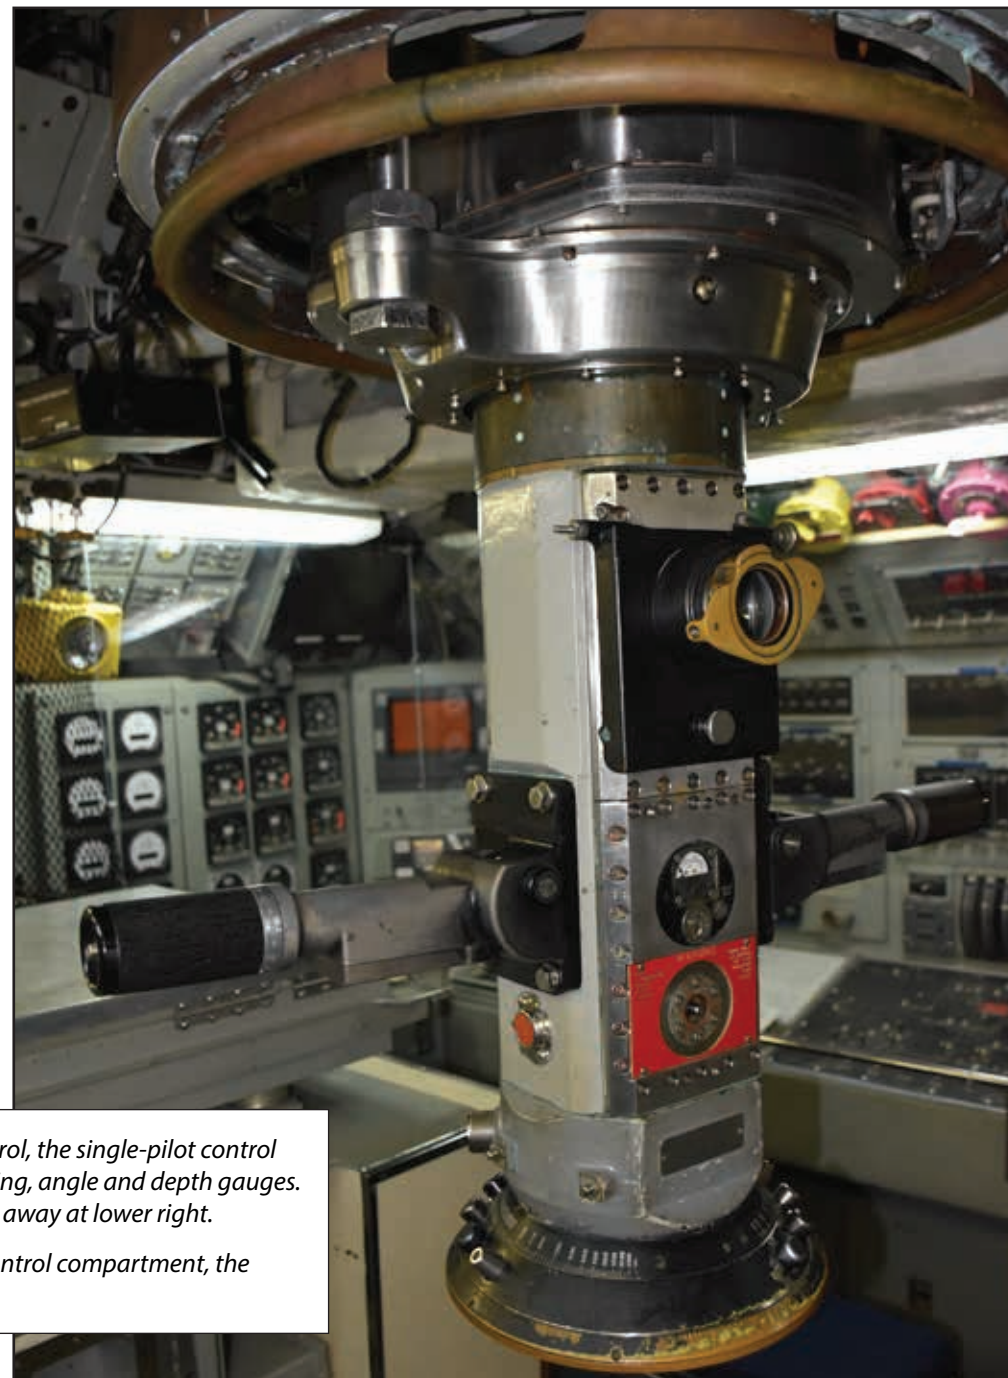
Right: In the center of the control compartment, the periscope.

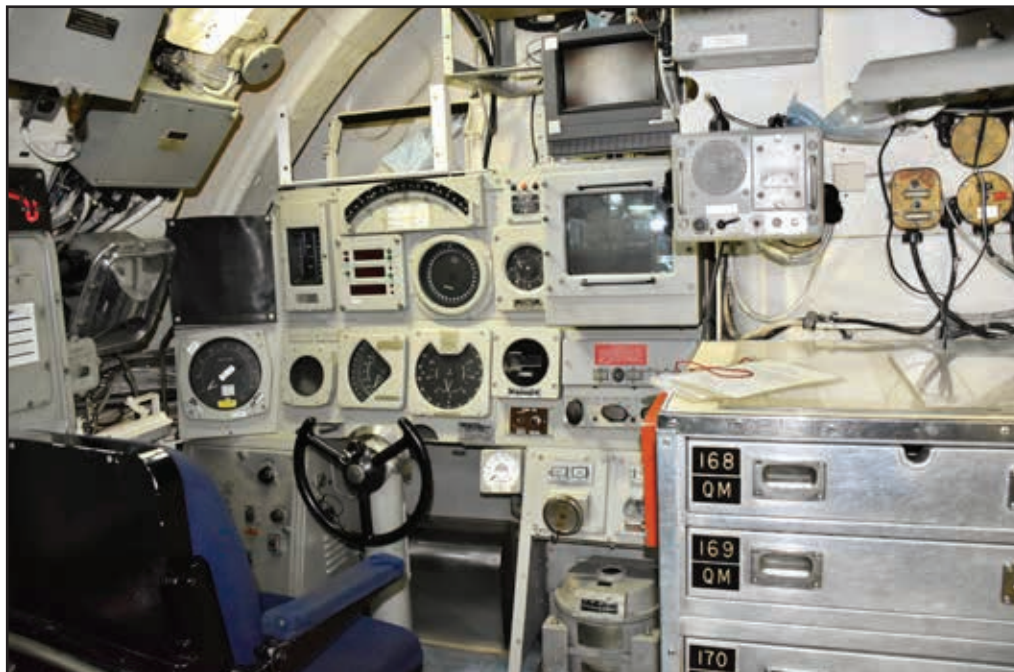
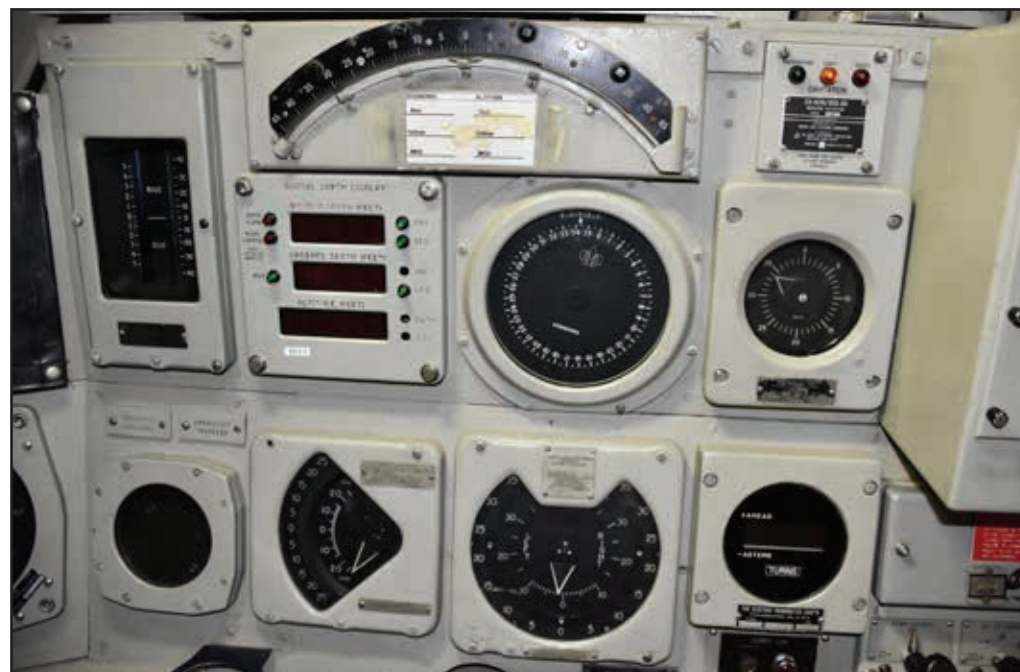
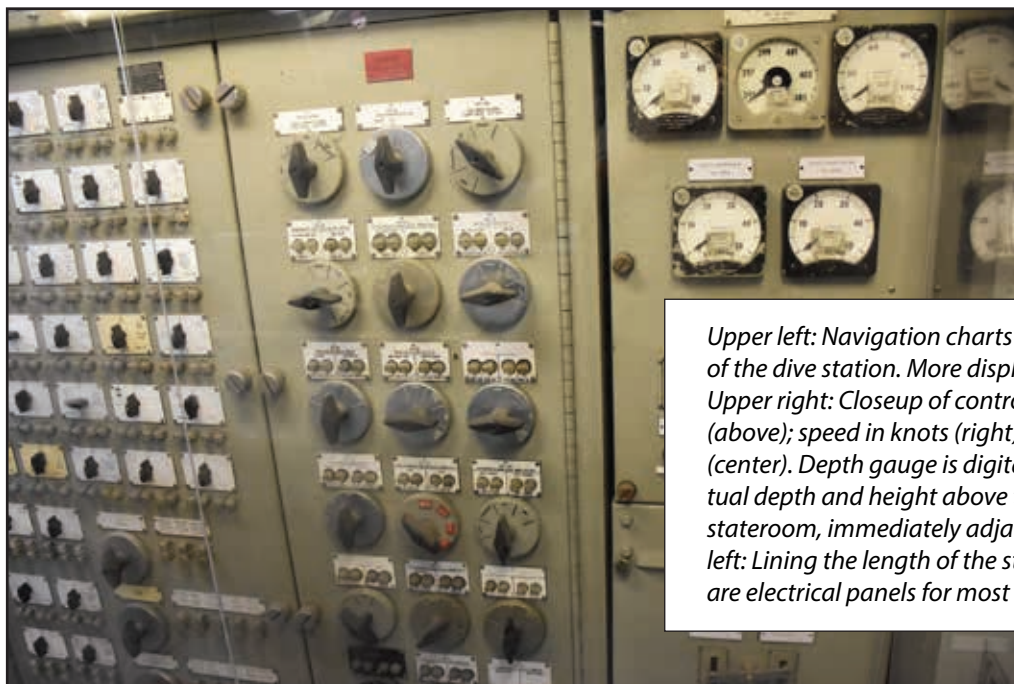
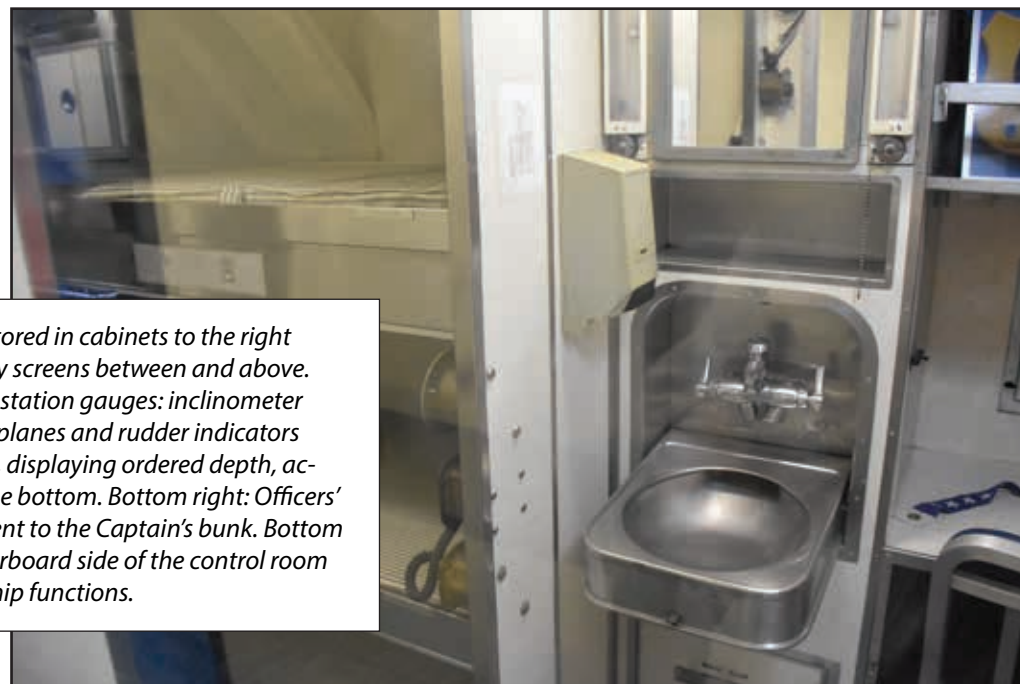
Upper left: Navigation charts stored in cabinets to the right of the dive station. More display screens between and above. Upper right: Closeup of control station gauges: inclinometer (above); speed in knots (right); planes and rudder indicators (center). Depth gauge is digital, displaying ordered depth, actual depth and height above the bottom. Bottom right: Officers' stateroom, immediately adjacent to the Captain's bunk. Bottom left: Lining the length of the starboard side of the control room are electrical panels for most ship functions.

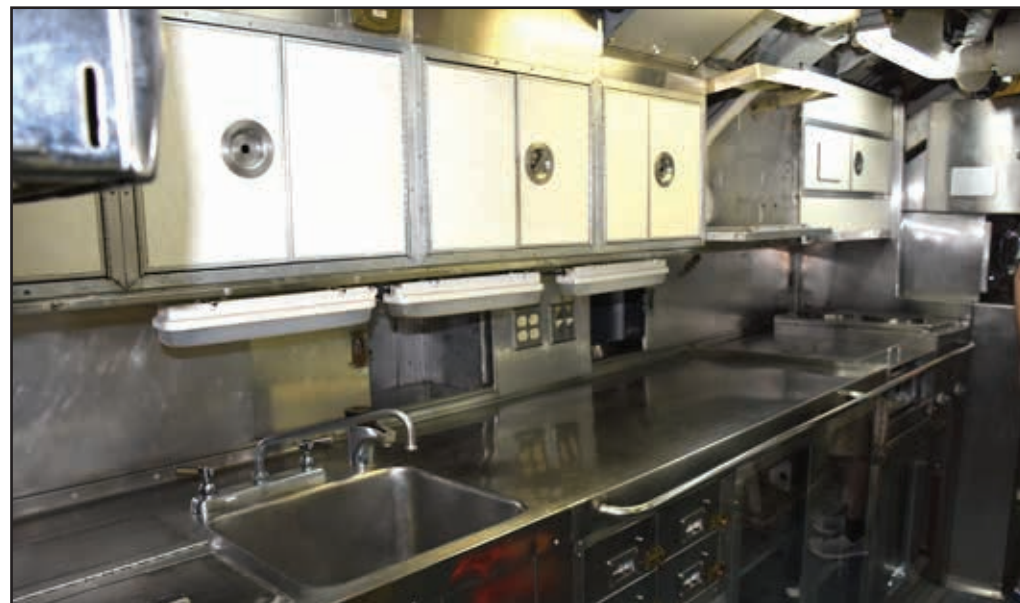
Ship's galley. It is an unusual "in-line" setup which lines the starboard side of the long hallway running fore and aft: cooking while the same space serves as a passageway!

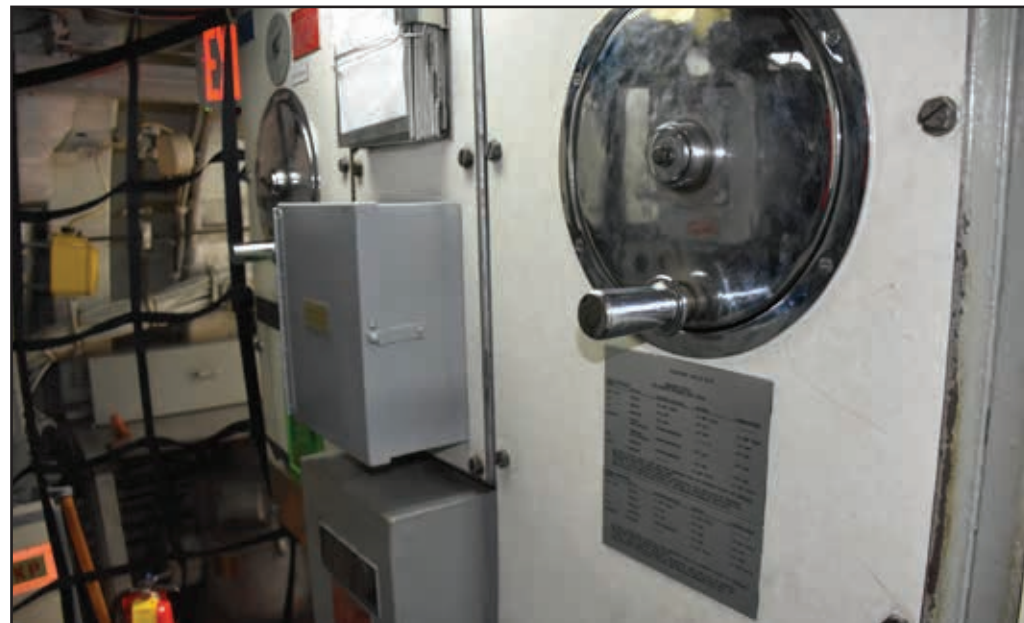
Controls for the two diesel-electric motor sets. Most engine and electrical controls are forward in the control room.

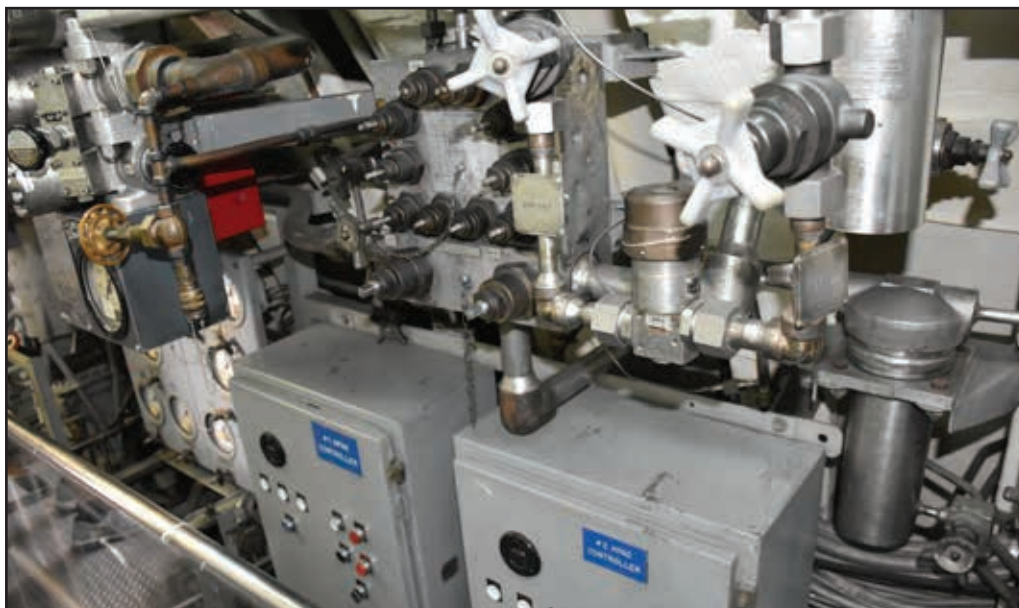
Air control systems (HPAC) stations in the engineering space.

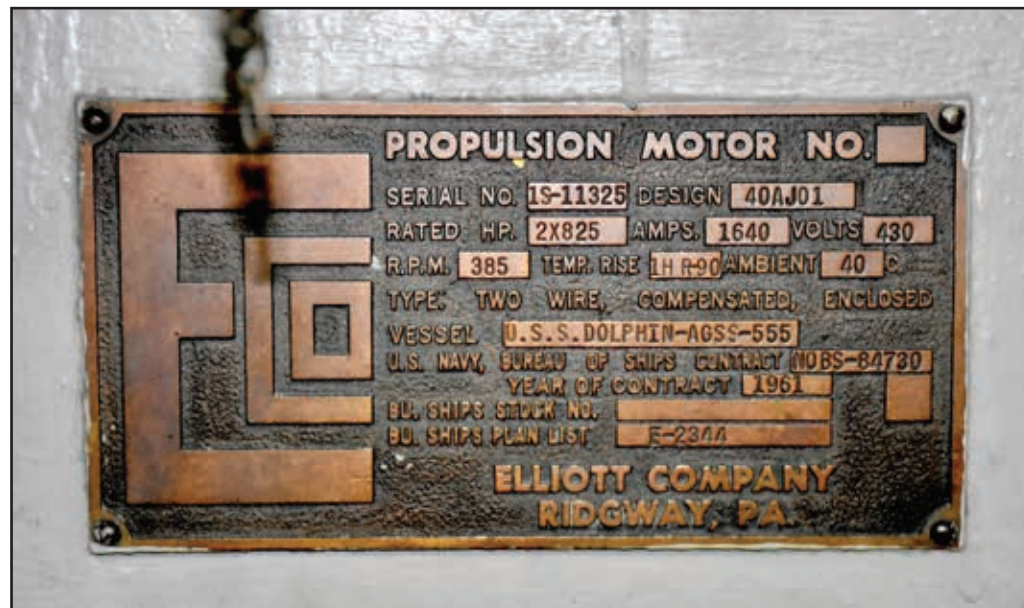
Plate mounted on the electric motor with specs for the unit.

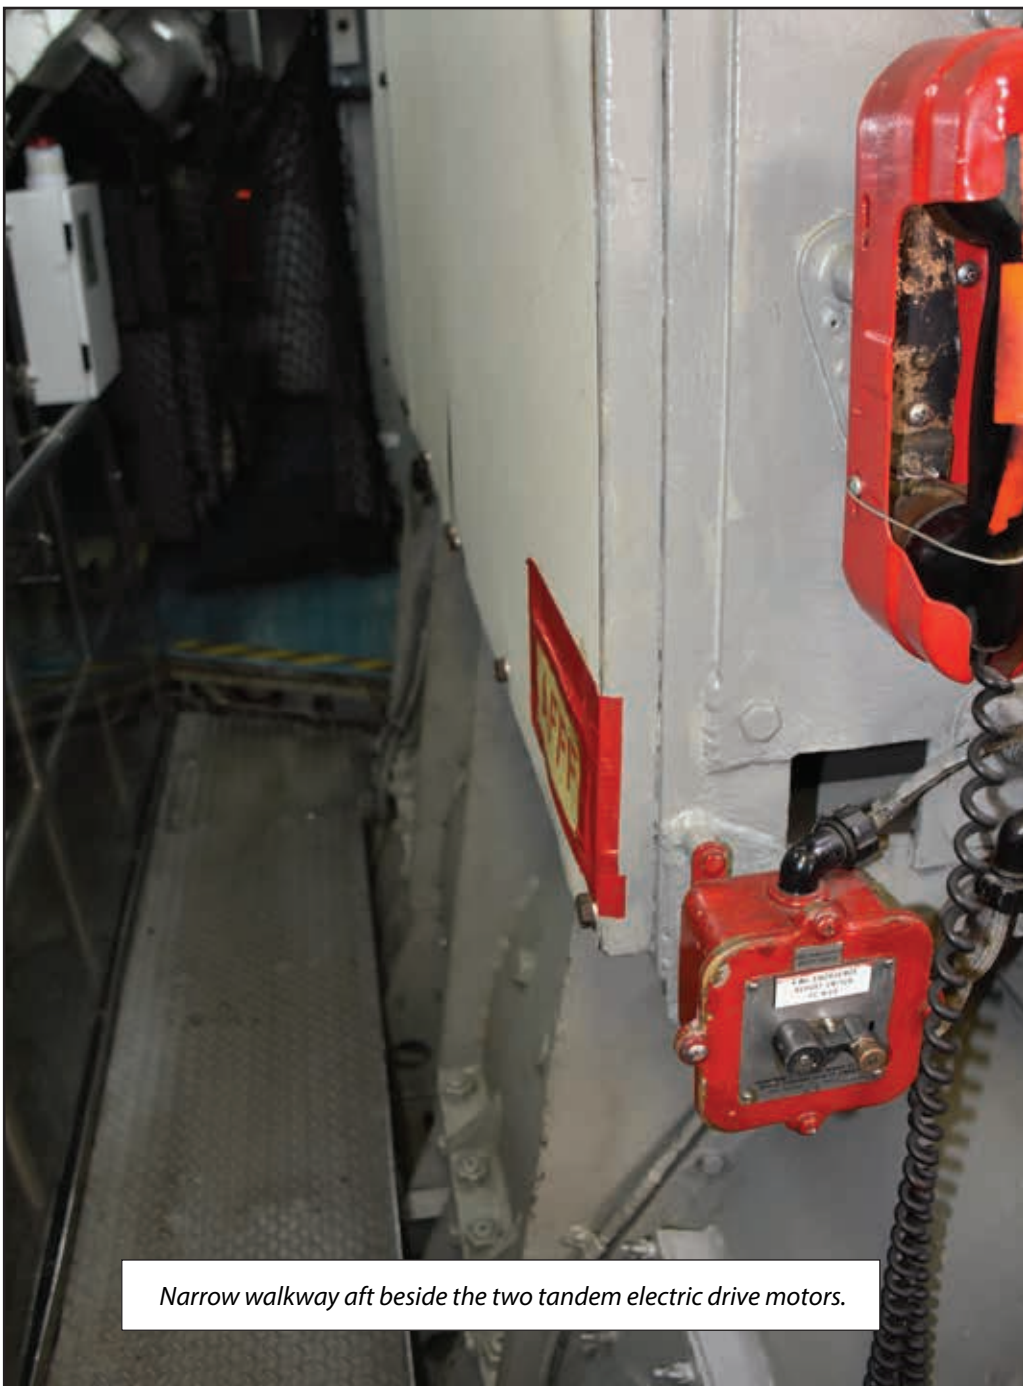
Narrow walkway aft beside the two tandem electric drive motors.

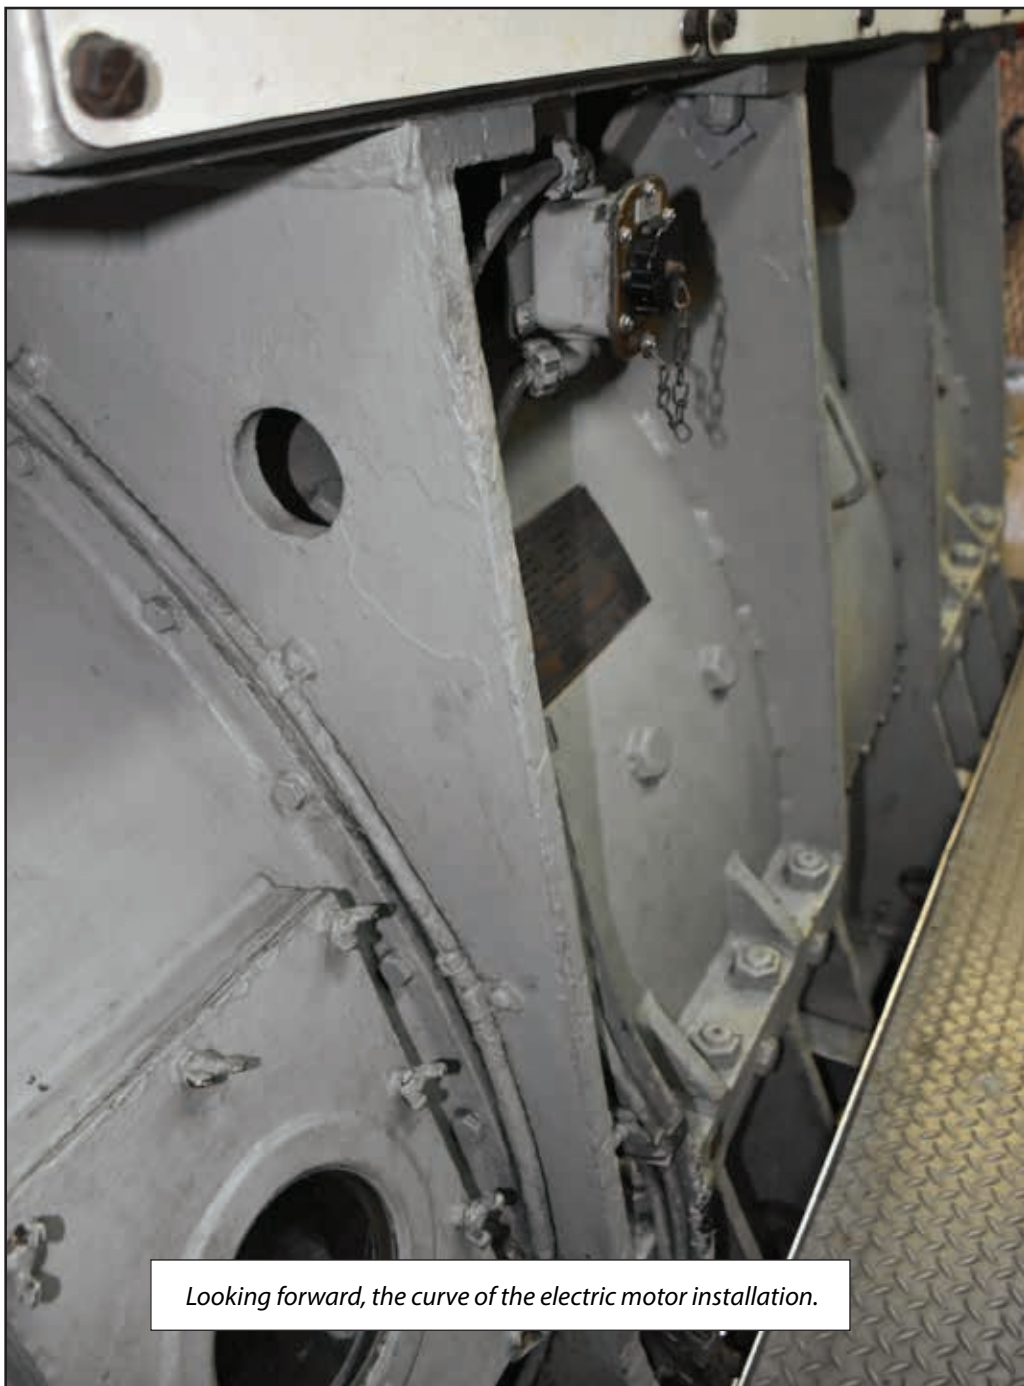
Looking forward, the curve of the electric motor installation.
